Showcasing Water Innovation

**Best Management Practices
Photo Journal**

UPPER THAMES RIVER
CONSERVATION AUTHORITY

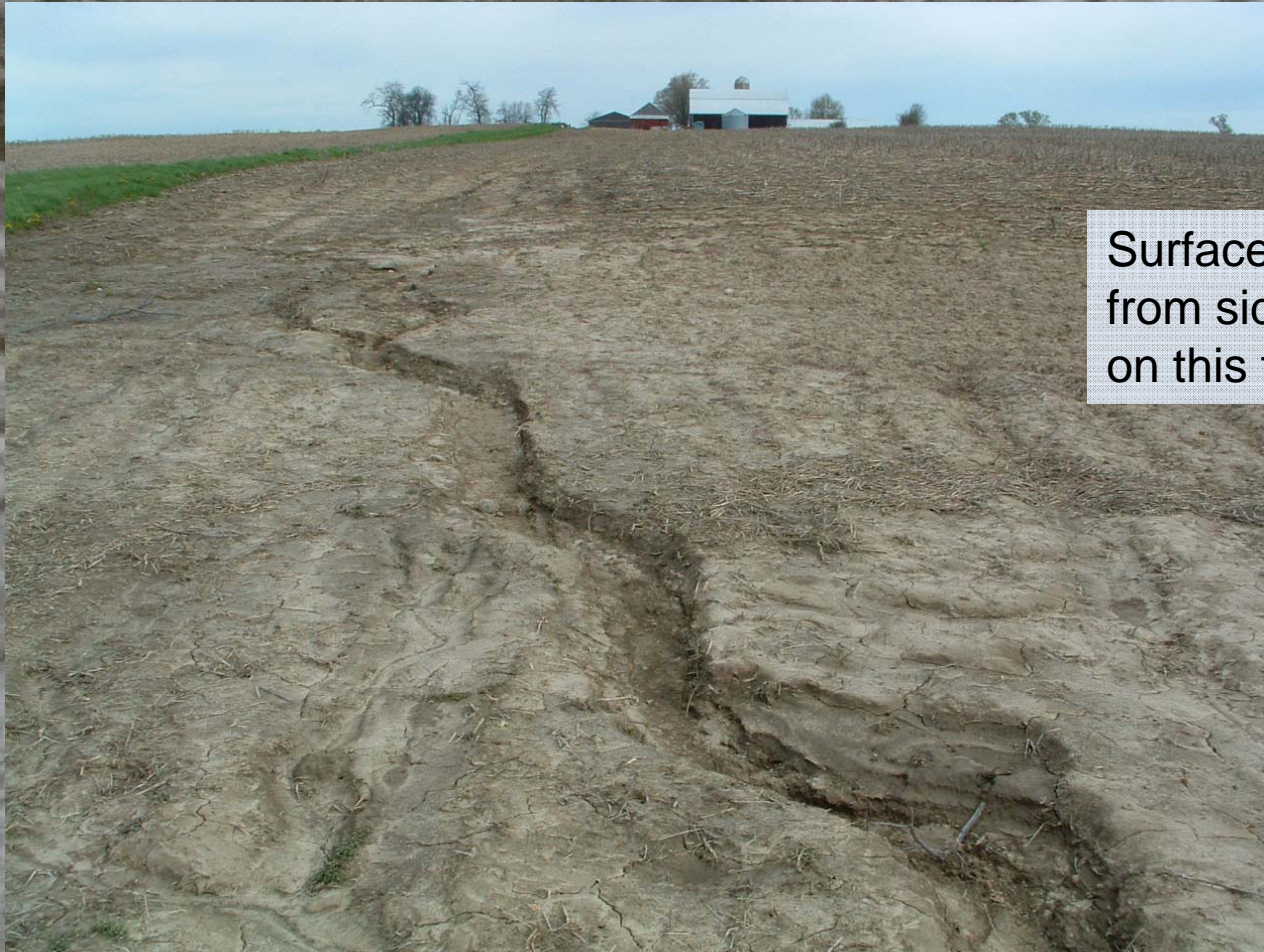
Site 1: Before (Upslope)

Surface erosion
from side slopes
on this farm field.

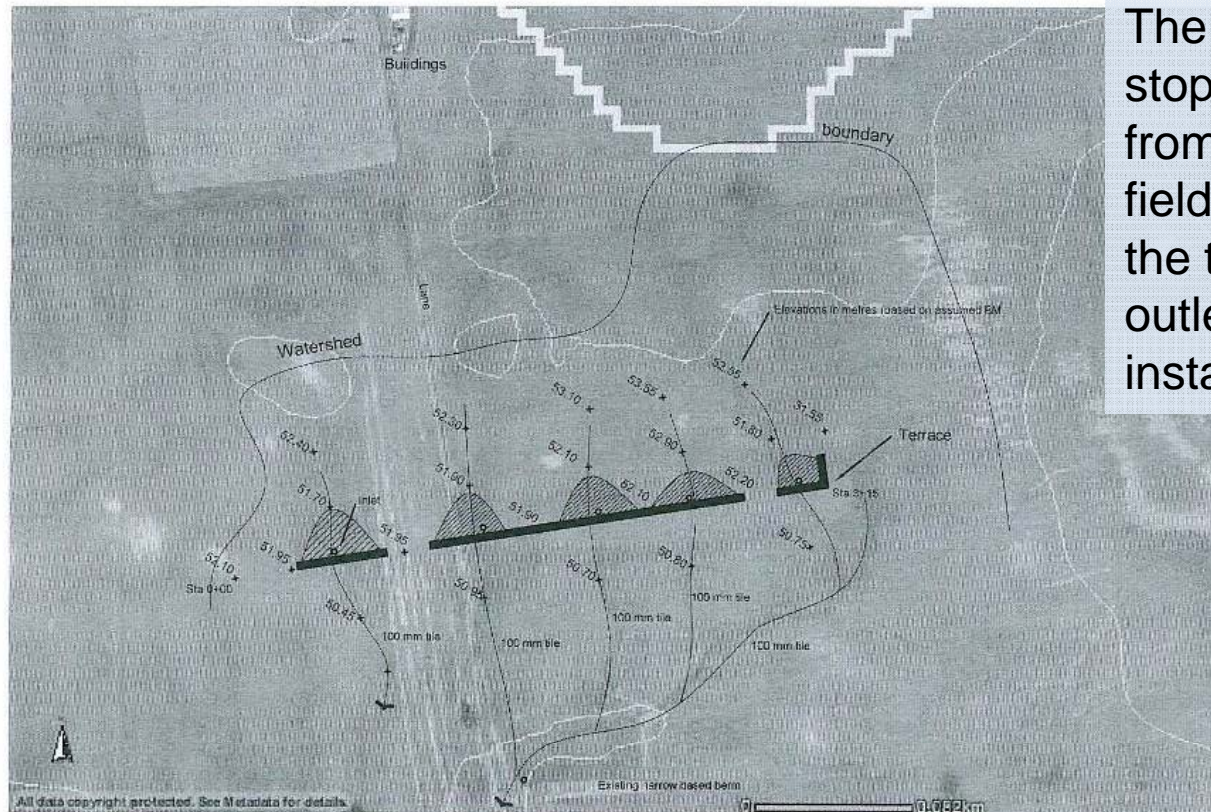
Site 1: Site Plan

The long terraces stop surface runoff from eroding the field downslope of the terrace. Five outlets pipes were installed.

Notes: Existing laneway will need to be incorporated into berm construction.

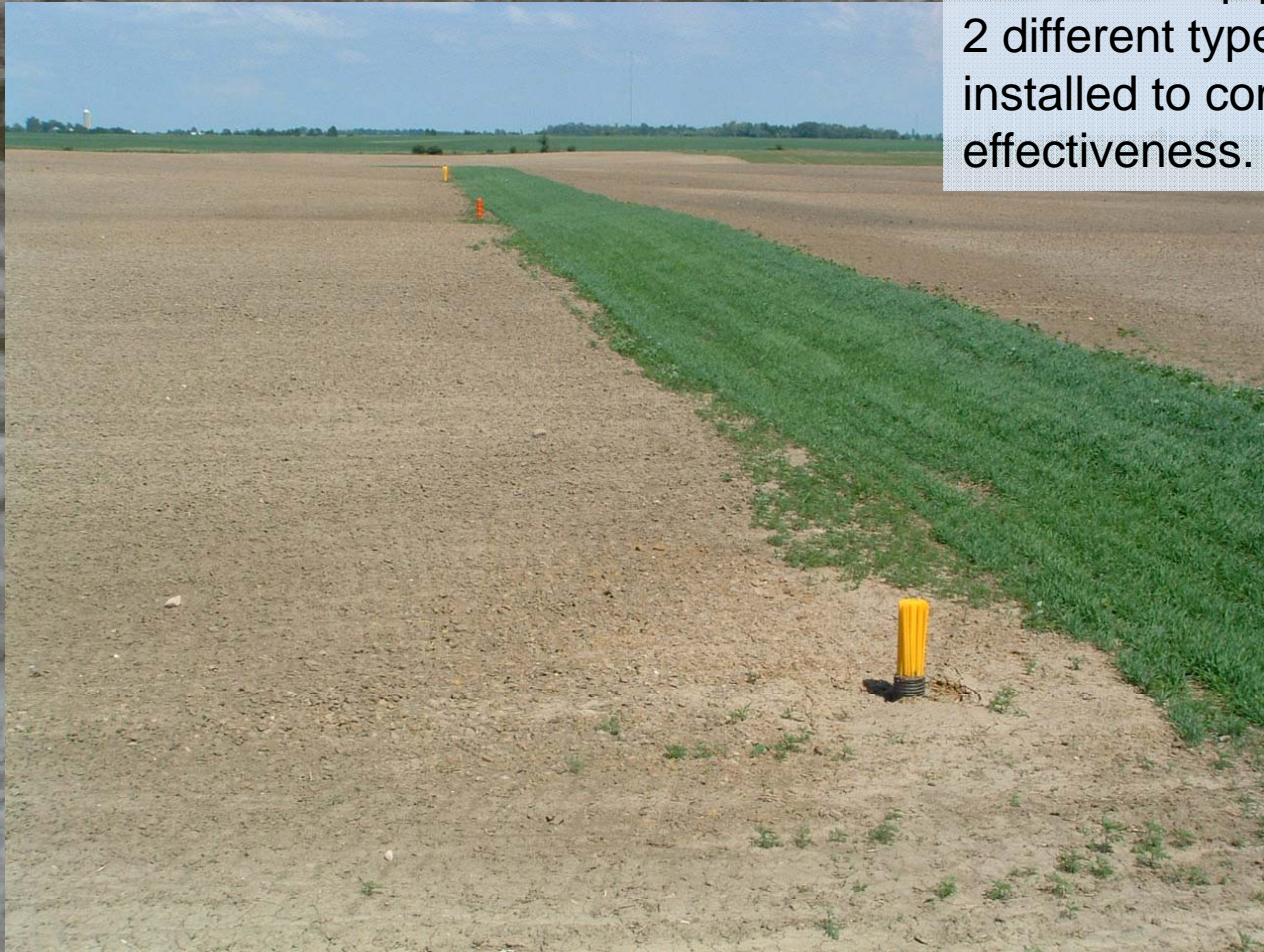
Site 1: After

Outlet standpipes –
2 different types were
installed to compare
effectiveness.

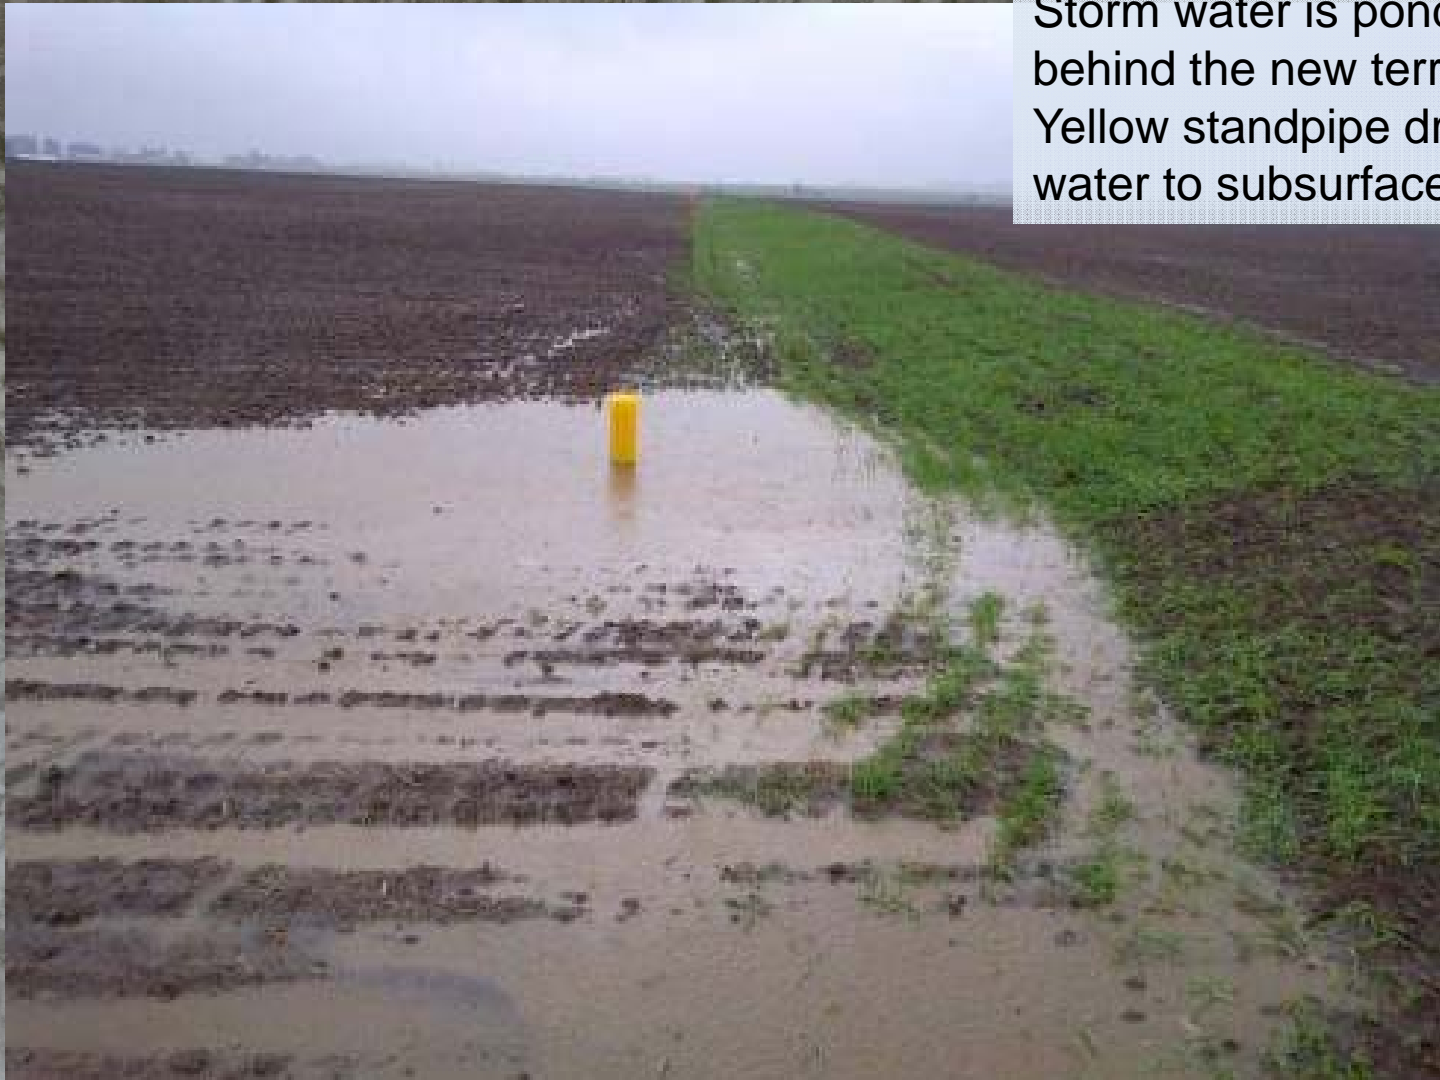
Site 1: After

Storm water is ponded behind the new terrace. Yellow standpipe drains water to subsurface tile.

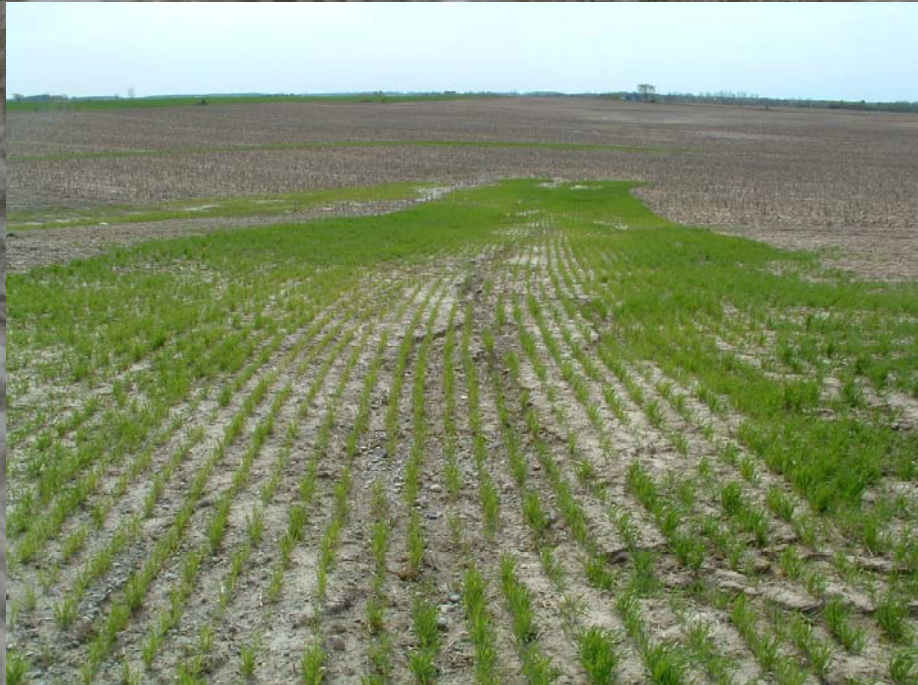
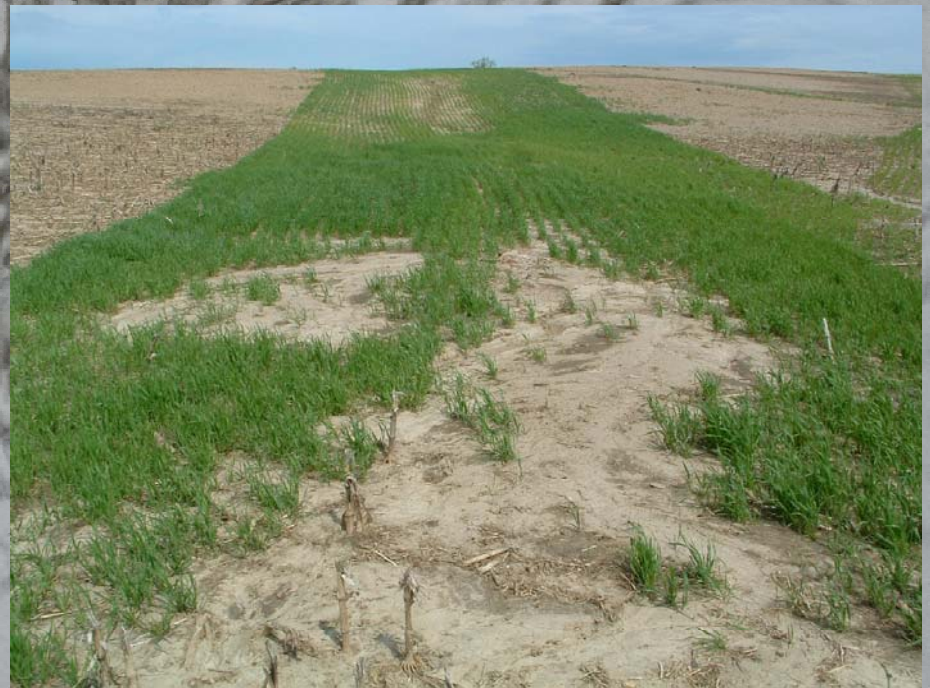
Site 2: Before (Field Cut and Soil Loss)

The landowner planted a cover crop in the eroded area in an unsuccessful attempt to slow surface runoff and gully erosion.

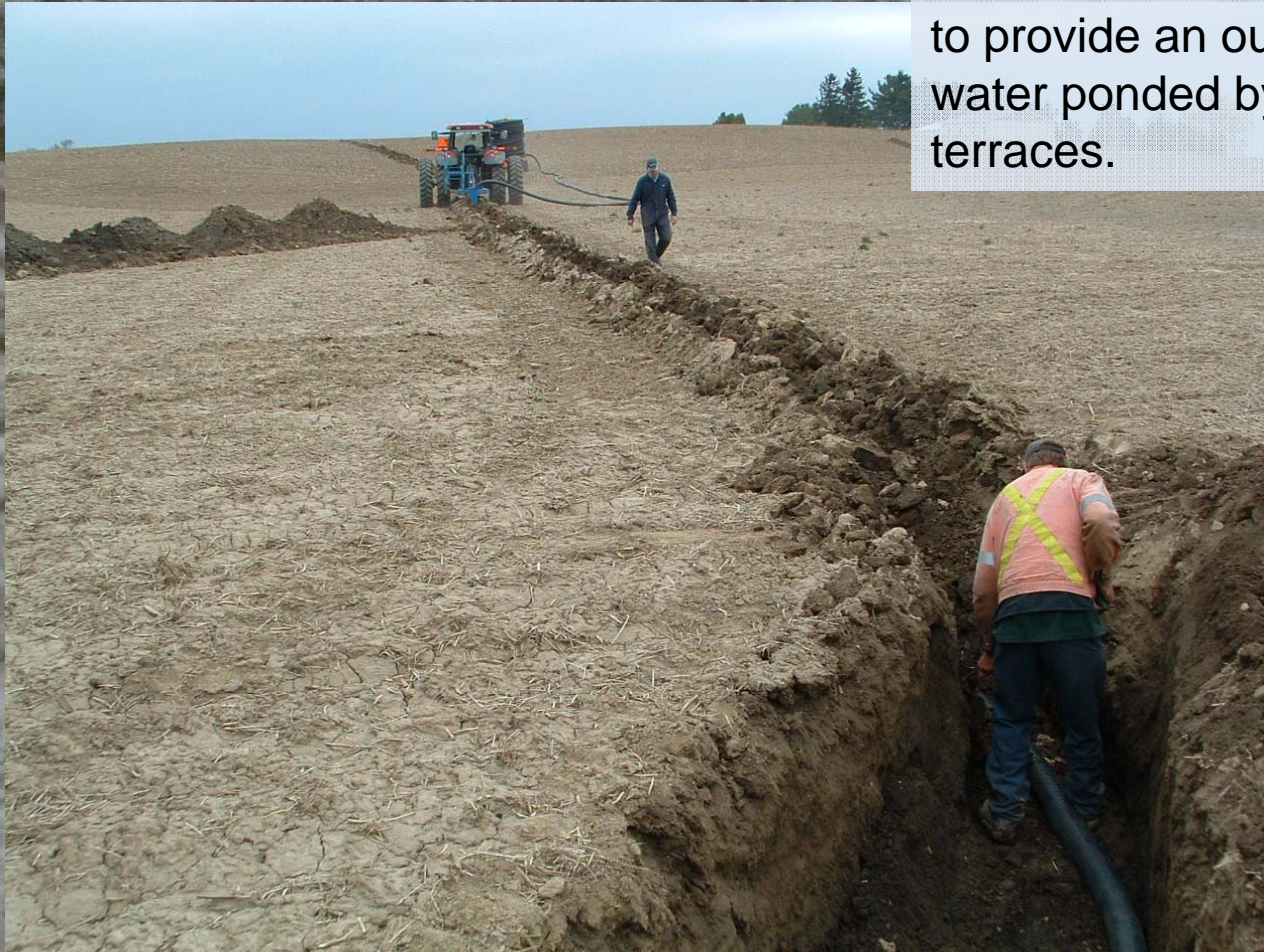
Site 2: Tile Installation

Plastic 4" tile was installed to provide an outlet for the water ponded by the new terraces.

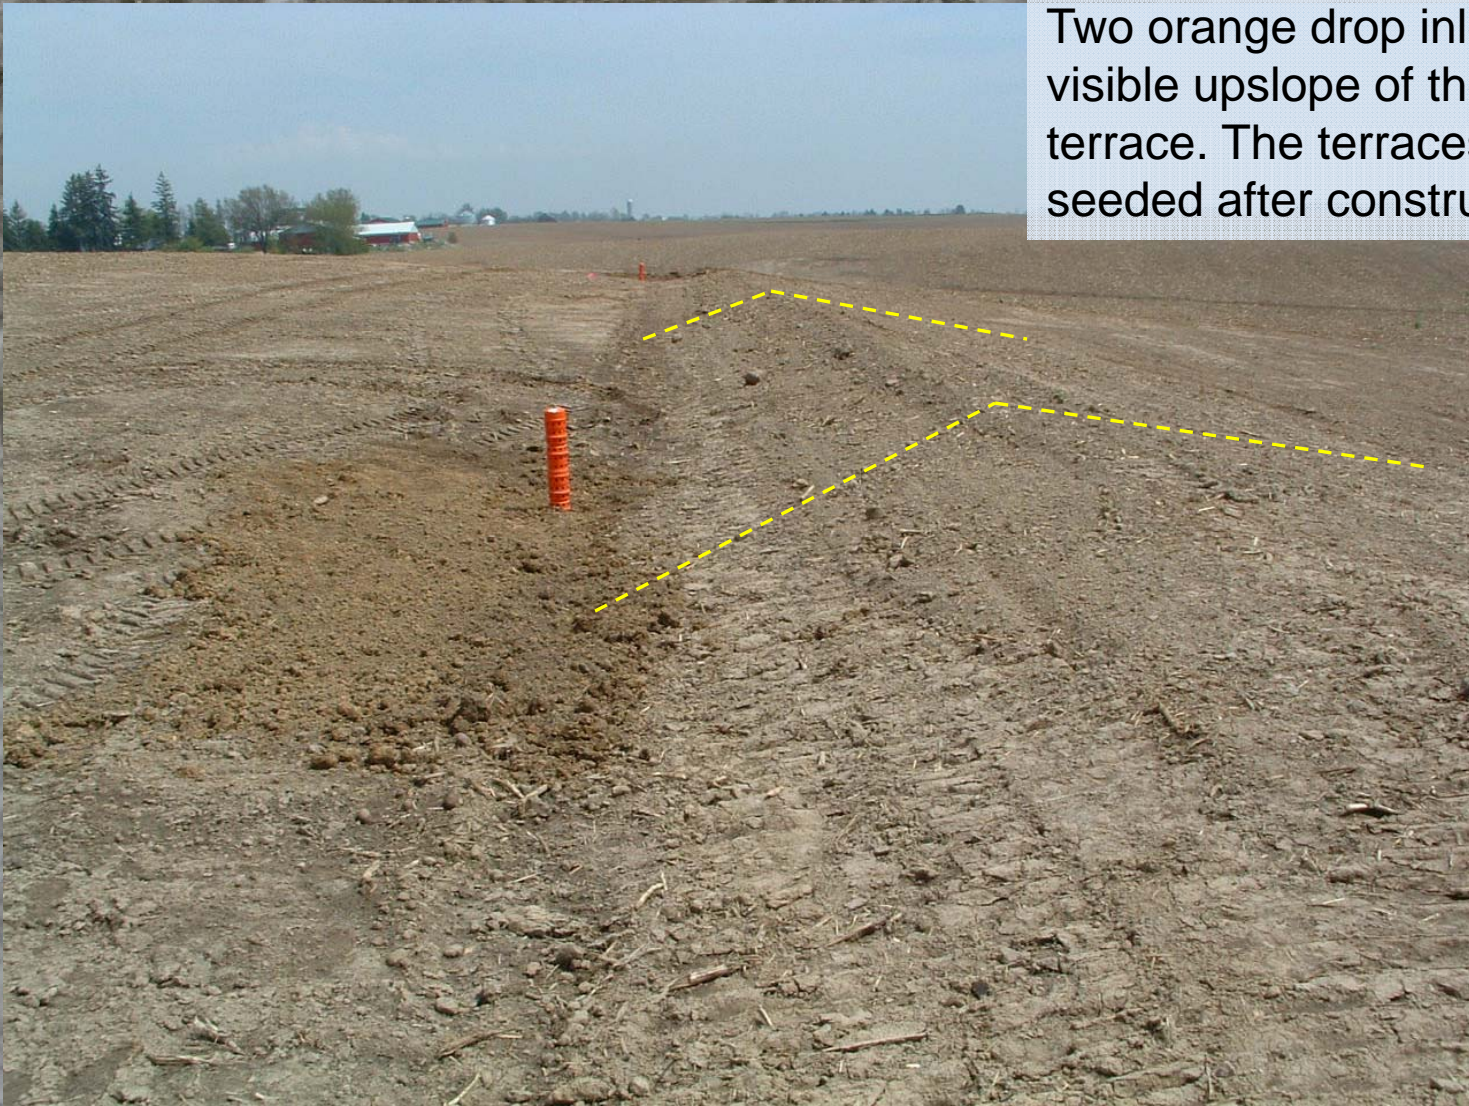
Site 2: Construction

Two orange drop inlets are visible upslope of the terrace. The terraces were seeded after construction.

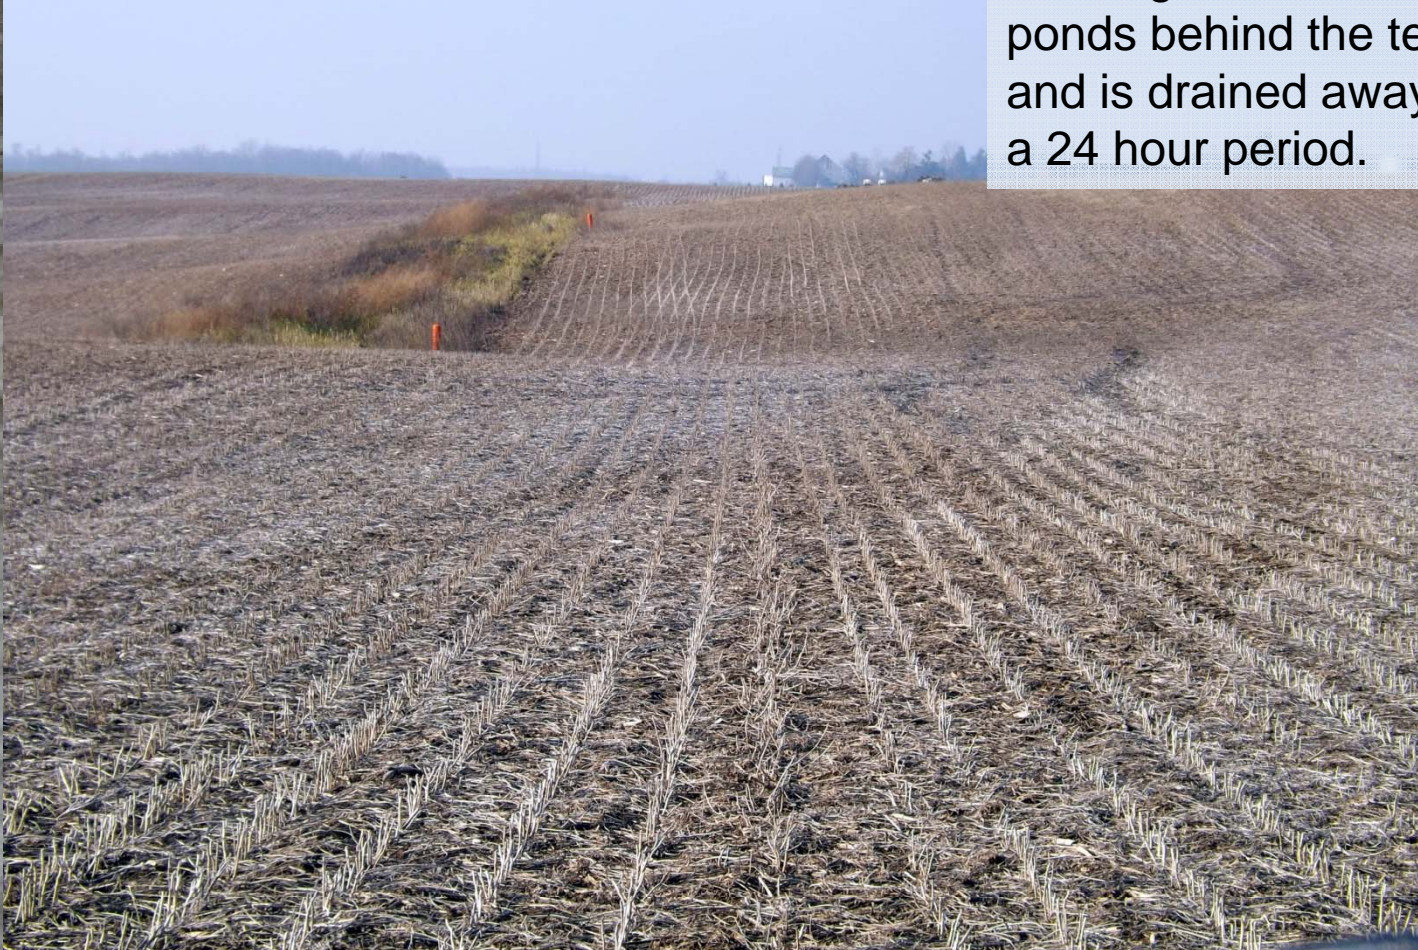
Site 2: After

Looking west: Water ponds behind the terraces and is drained away over a 24 hour period.

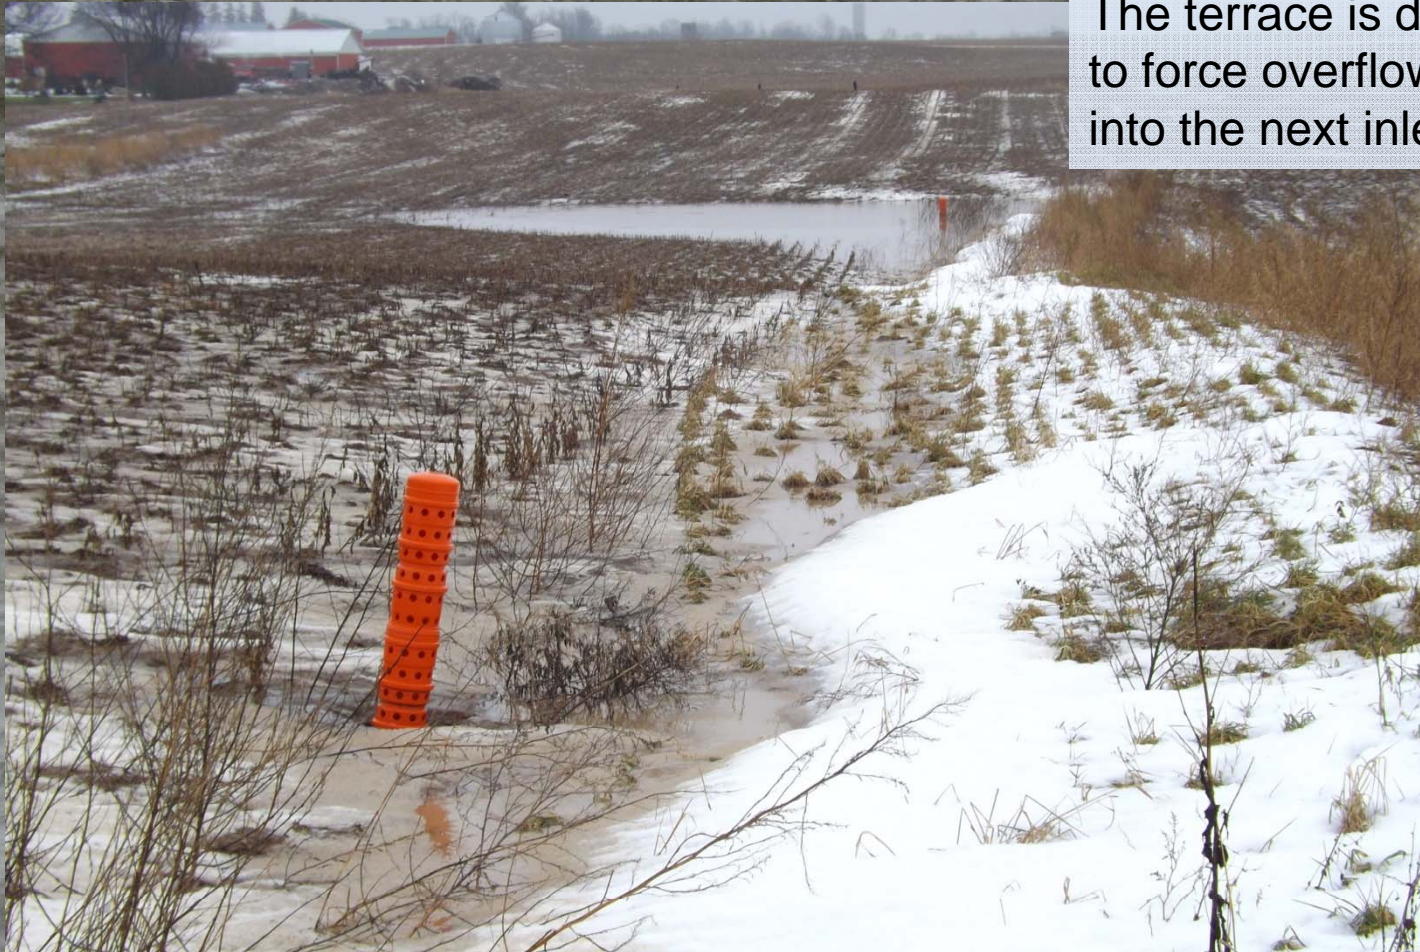
Site 2: After

Looking east after a winter rainfall event:
The terrace is designed to force overflow water into the next inlet.

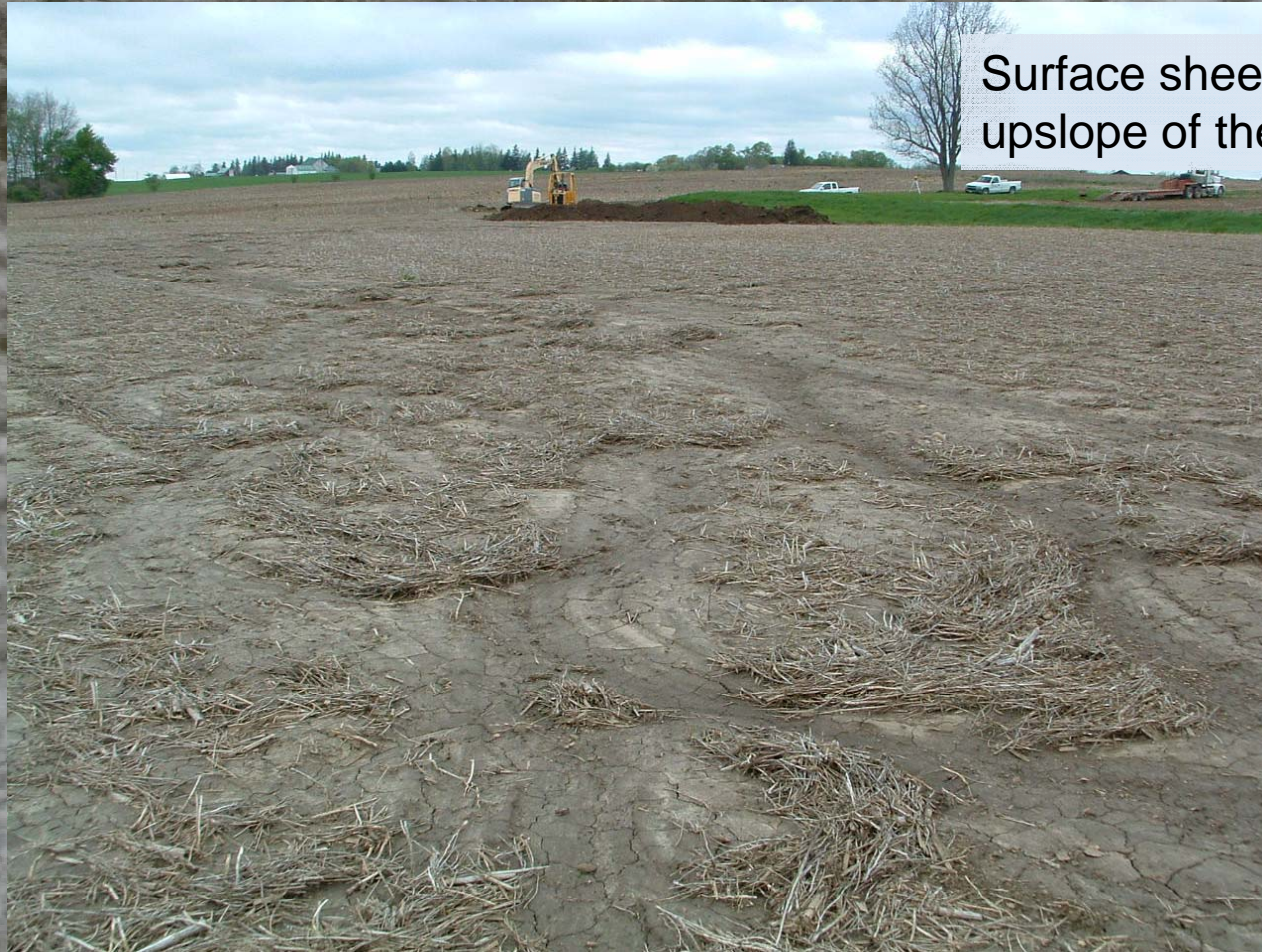
Site 3: Before (Upslope)

Surface sheet erosion
upslope of the new berm.

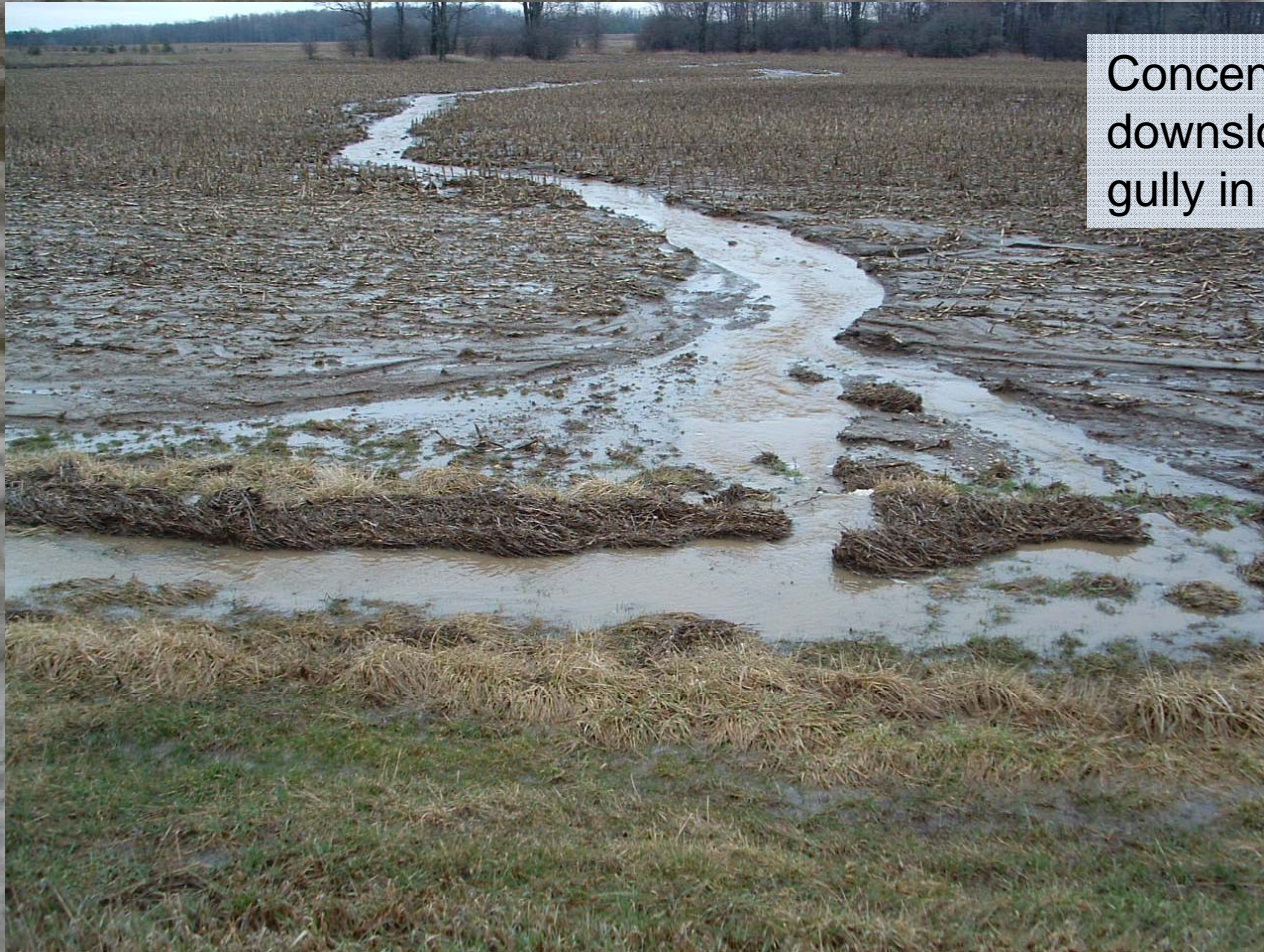
Site 3: Before (Downslope)

Concentrated flows
downslope cut a
gully in the field.

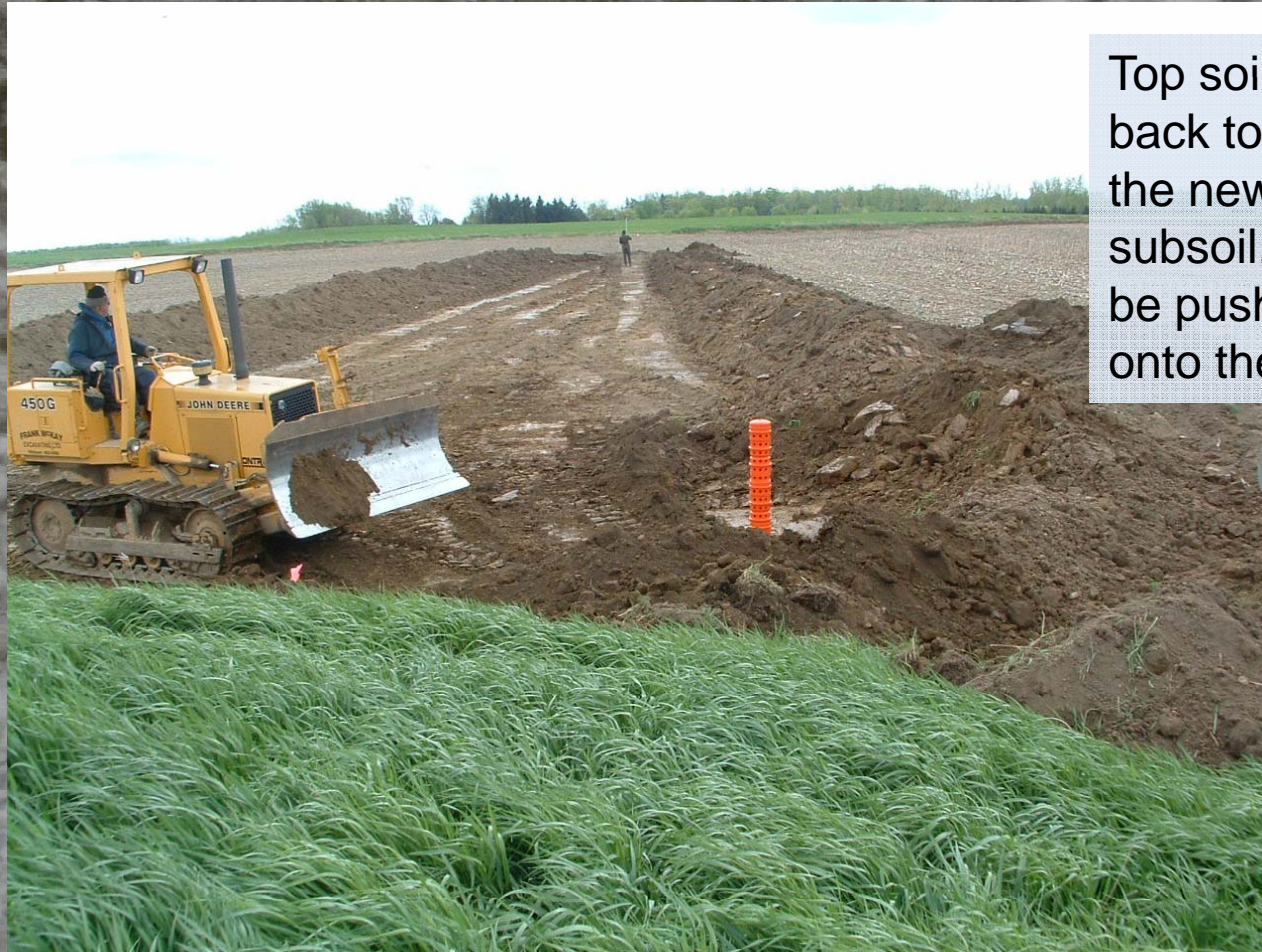
Site 3: Construction

Top soil is stripped back to construct the new berm with subsoil. Top soil will be pushed back onto the new berm.

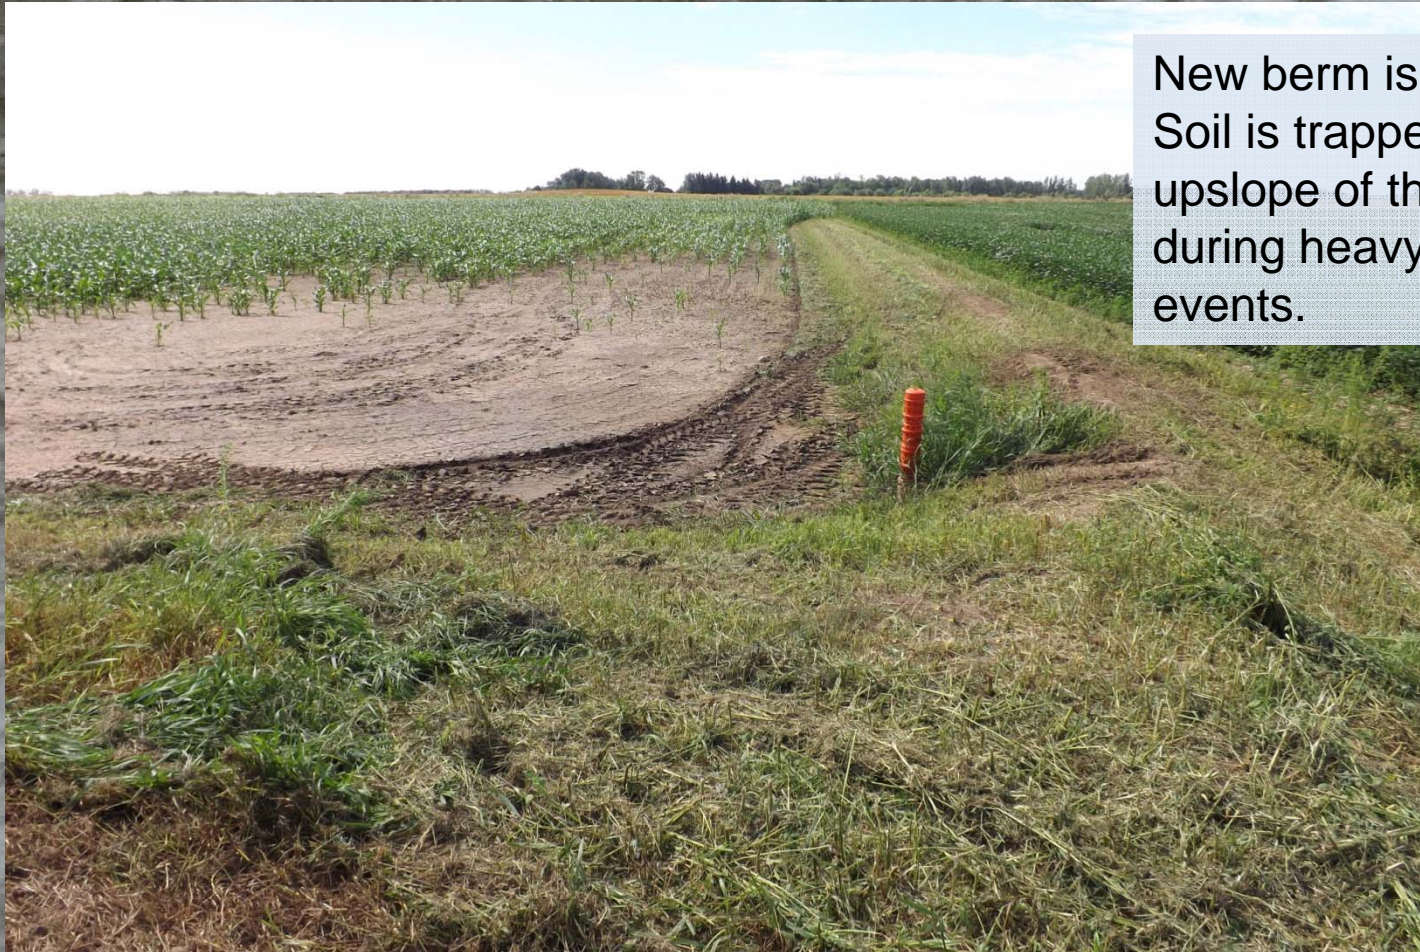
Site 3: After

New berm is seeded.
Soil is trapped
upslope of the berm
during heavy rainfall
events.

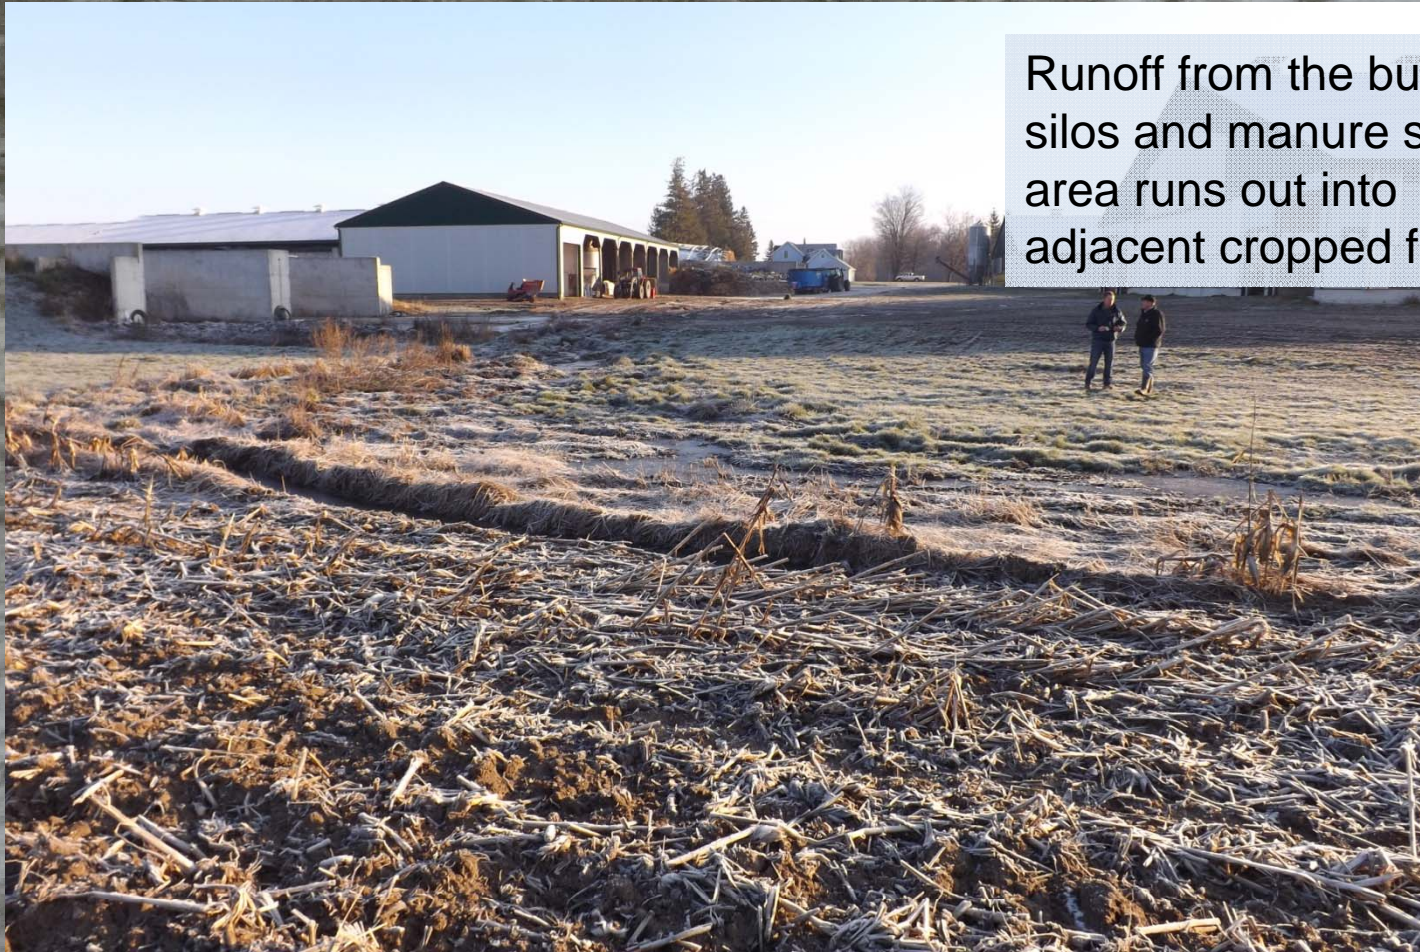
Site 4: Before

Runoff from the bunker silos and manure storage area runs out into adjacent cropped field.

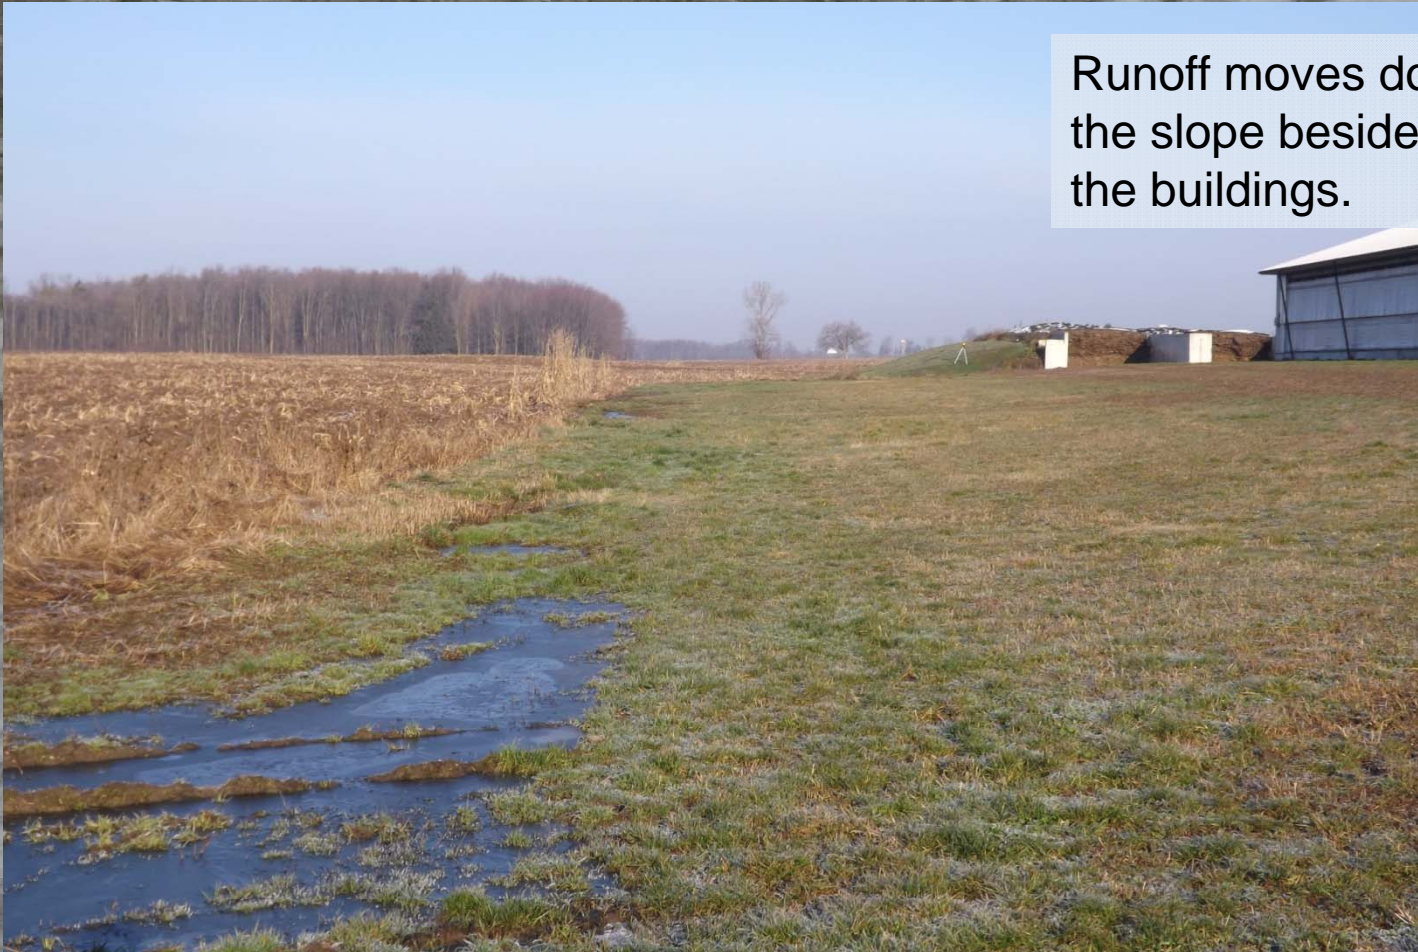
Site 4: Before

Runoff moves down the slope beside the buildings.

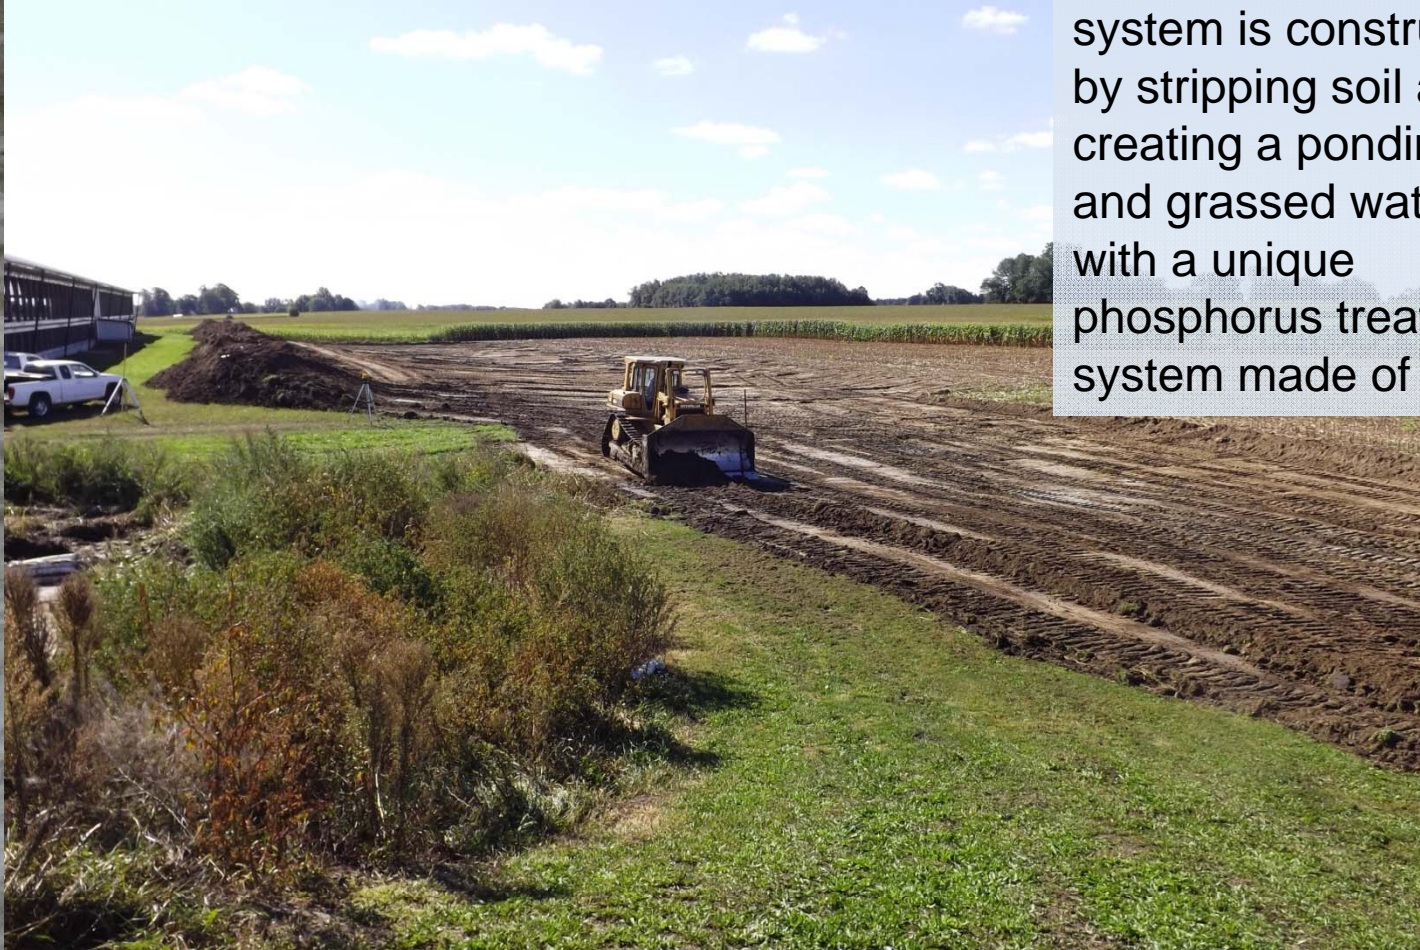
Site 4: Construction

Runoff treatment system is constructed by stripping soil and creating a ponding area and grassed waterway with a unique phosphorus treatment system made of slag.

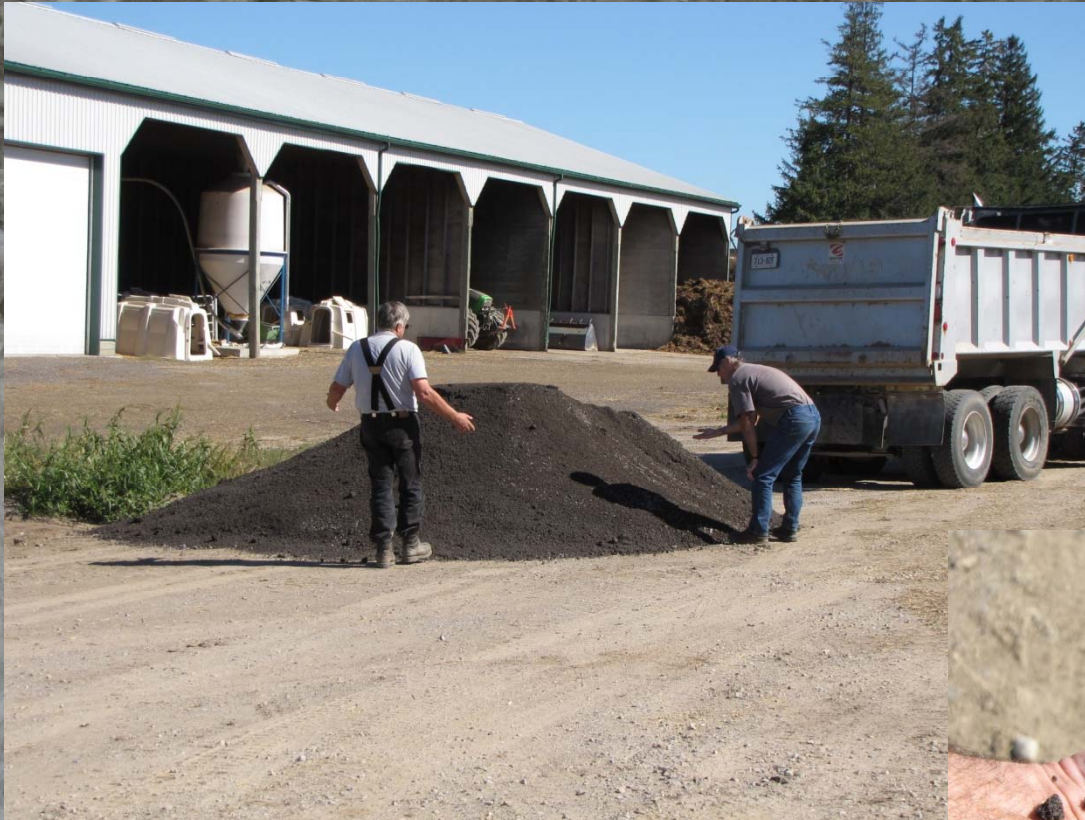
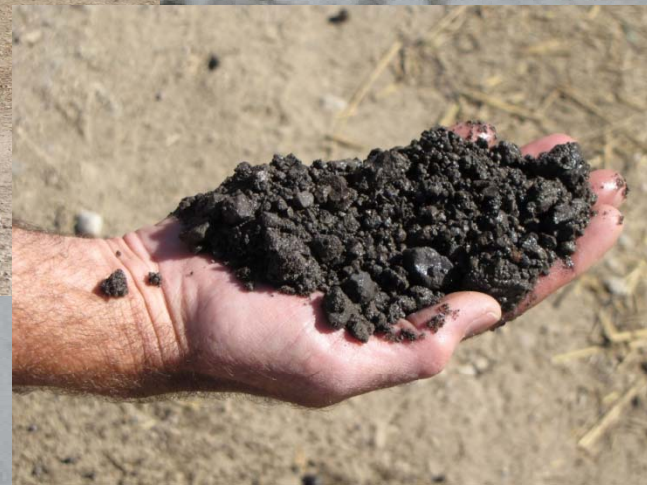
Site 4: Treatment of Phosphorus

Slag is used to 'bind' the phosphorus in the contaminated runoff. A trench full of slag will be installed at the top end of the grassed waterway.
