Showcasing Water Innovation

**Best Management Practices
Photo Journal**

UPPER THAMES RIVER
CONSERVATION AUTHORITY

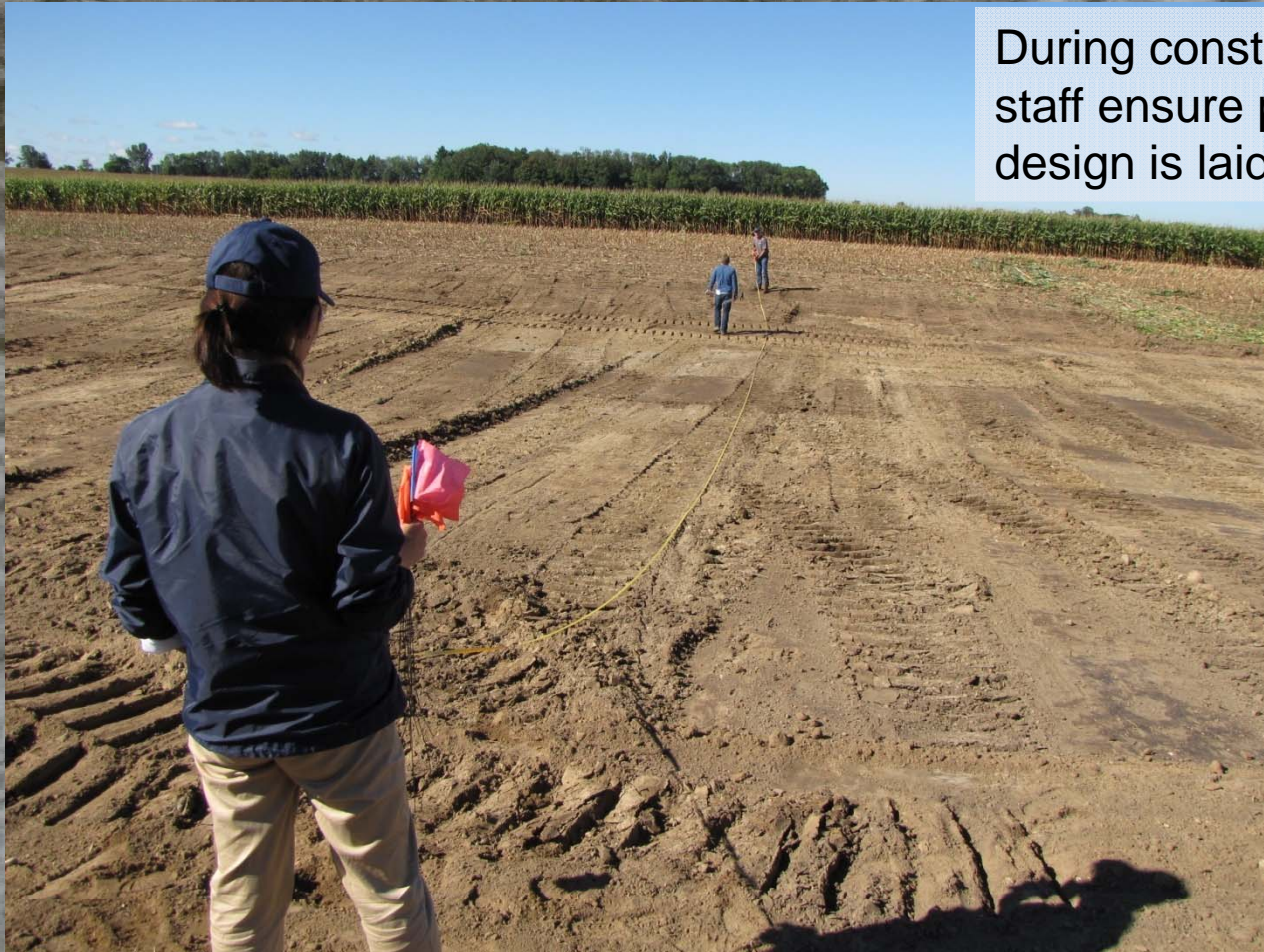
Site 4: Construction

During construction, staff ensure proper design is laid out.

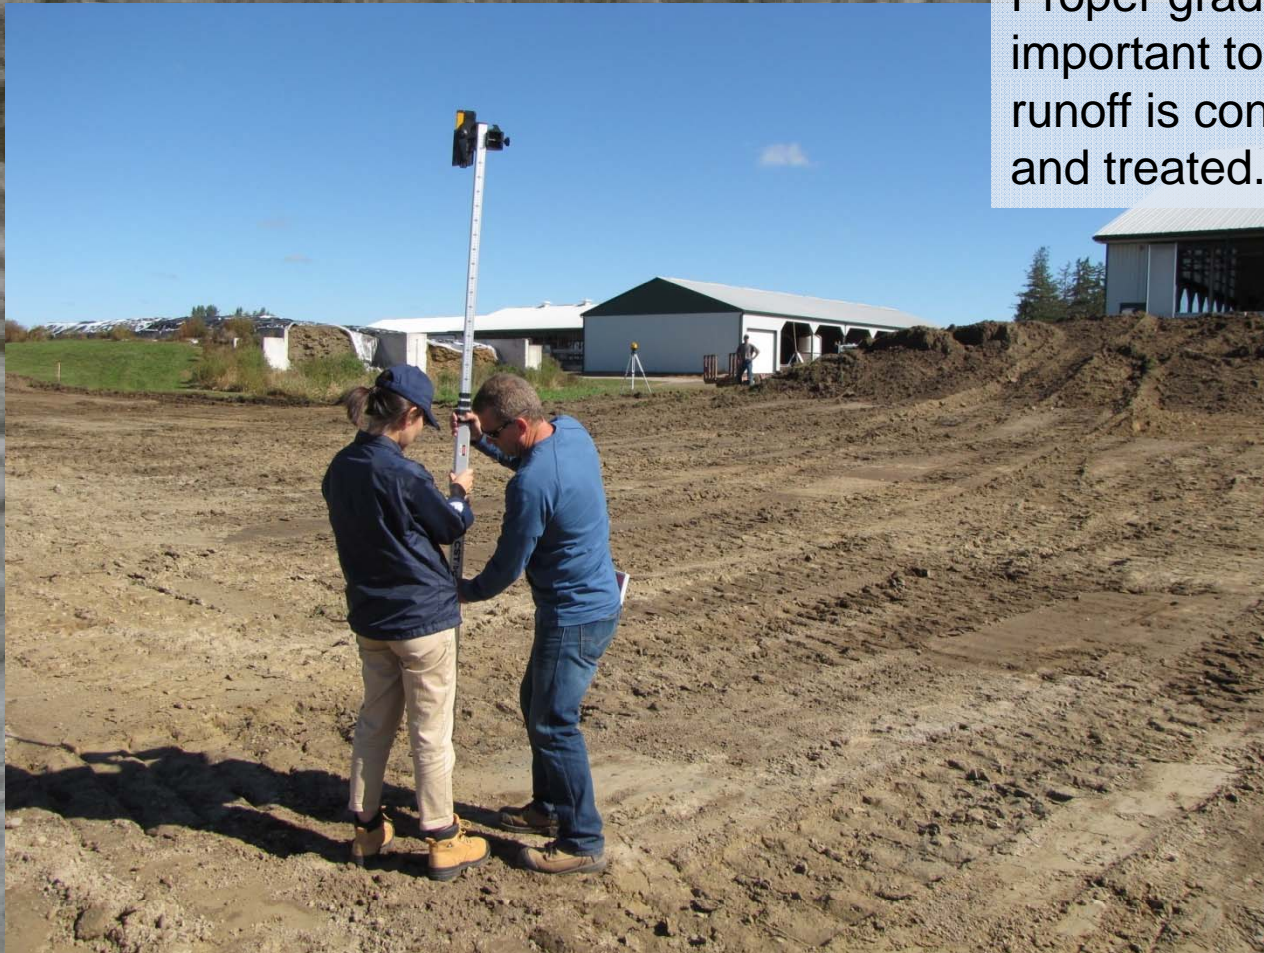
Site 4: Construction

Proper grades are important to ensure runoff is contained and treated.

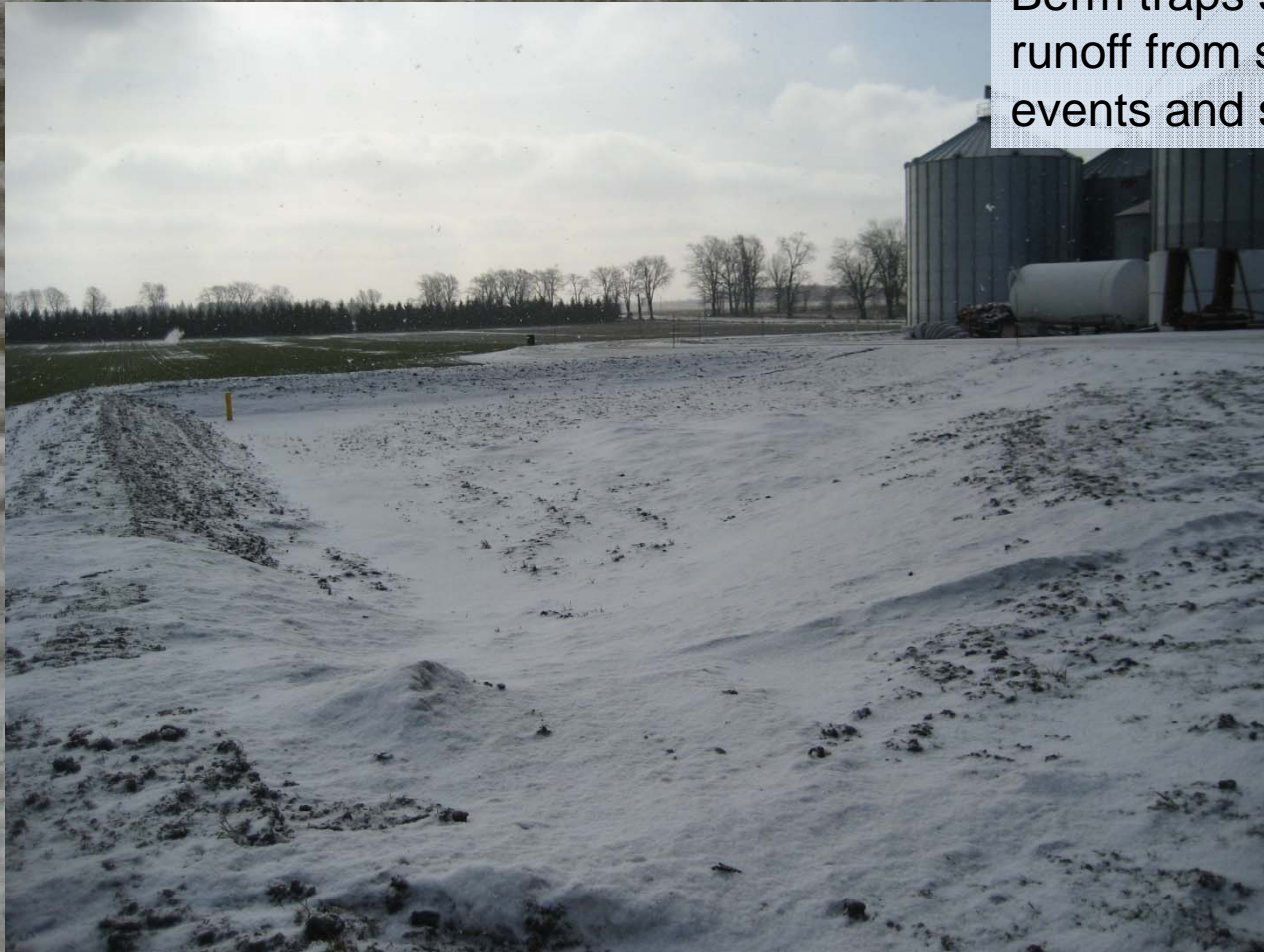
Site 5: After

Berm traps surface runoff from storm events and snow melt.
