# North Kettle Creek Watershed Evaluation Project

## Conservation Cropland Planning Options at Farm No. 1

### Field Analysis

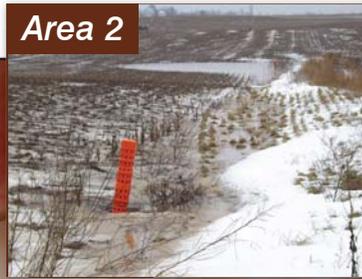
Area 2

Lidar is a remote sensing method that uses light to measure distances to the Earth. It was used as a tool to locate erosion 'hot spots' on this farm. Damage from concentrated flow paths can clearly be seen. The areas above these 'scars' on the landscape are good locations to consider structural erosion control measures such as terraces.

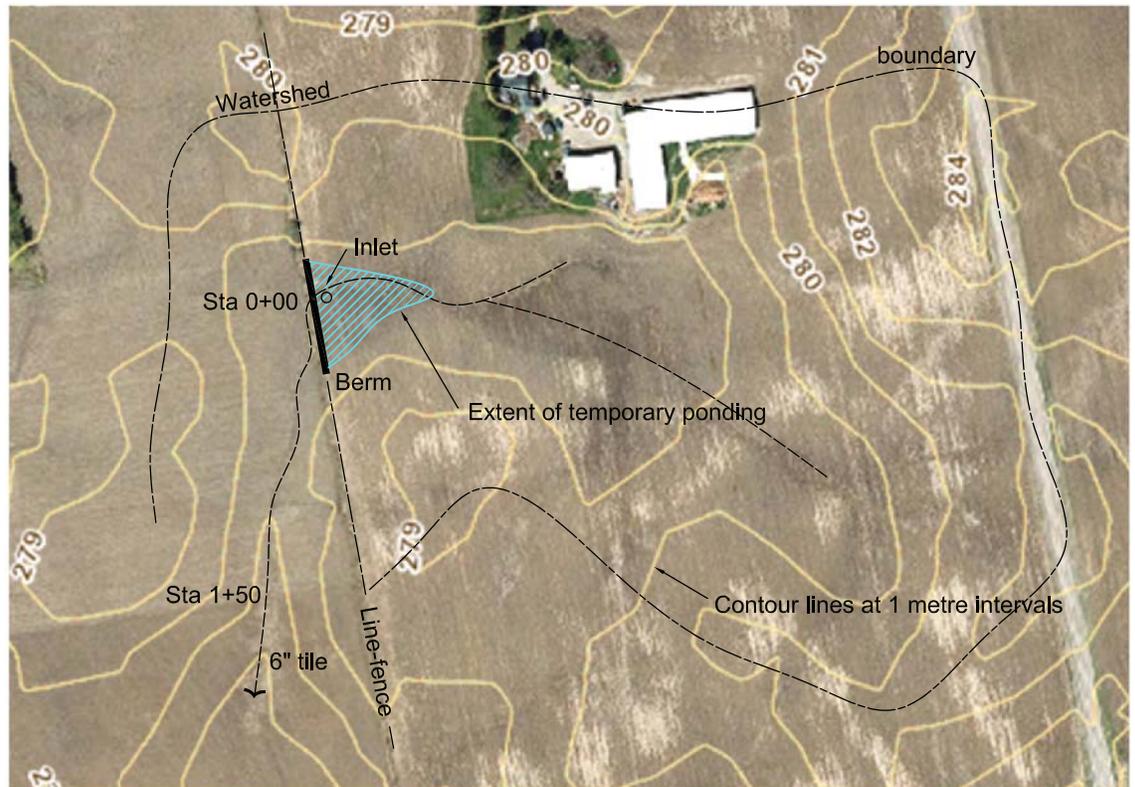
## Area 1

Rill erosion is occurring in a single drainageway with a 9 ha watershed that originates on the neighbouring farm to the east.

- Construct water and sediment control basin (WASCoB) on the fence line.
- Secure neighbour's permission.
- Install standpipe inlet and outlet into existing tile drainage system.

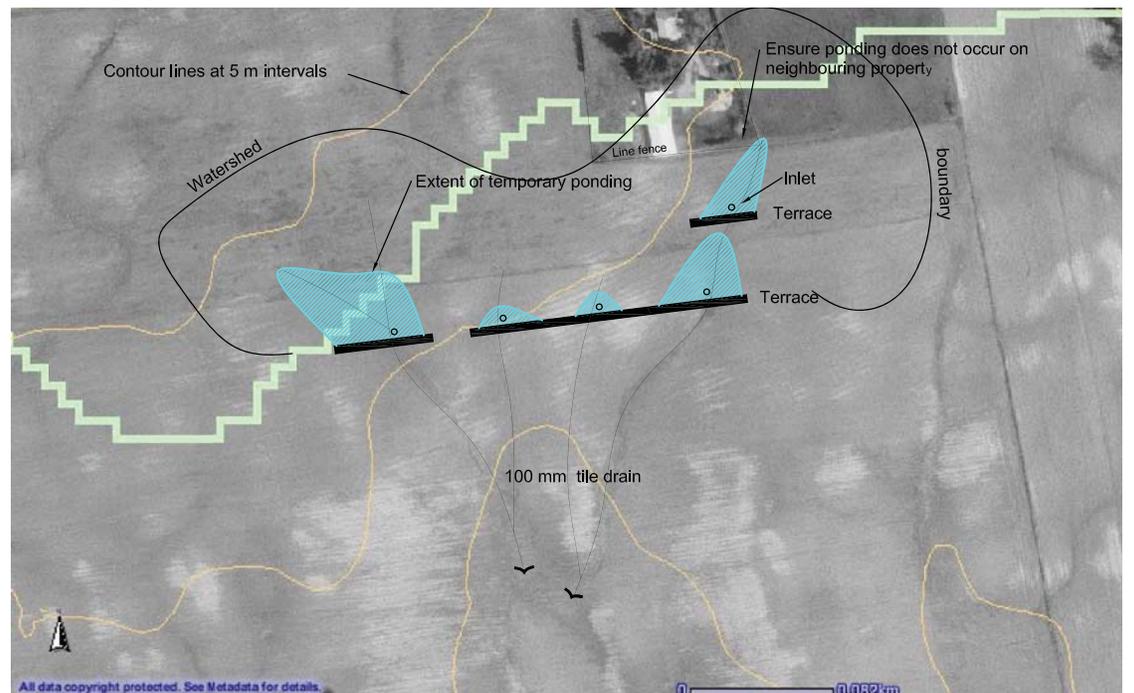
## Area 2

Significant sheet and rill erosion are occurring on the north slope of a large, bowl-like area. Based on the existing management, it is estimated using the Universal Soil Loss Equation that over 21 tons/acre average annual soil loss may be expected on this 5.5% slope.

- Construct a single, 240 m long narrow-based tile outlet terrace across the entire slope.
- Install four standpipe inlets (one in each distinct drainageway) and the necessary drainage tile for adequate outlet.
- Along the eastern-most drainageway, construct a second terrace 45 m upslope. This system will break up the slope by diverting surface water underground from over 3 ha of cropland.

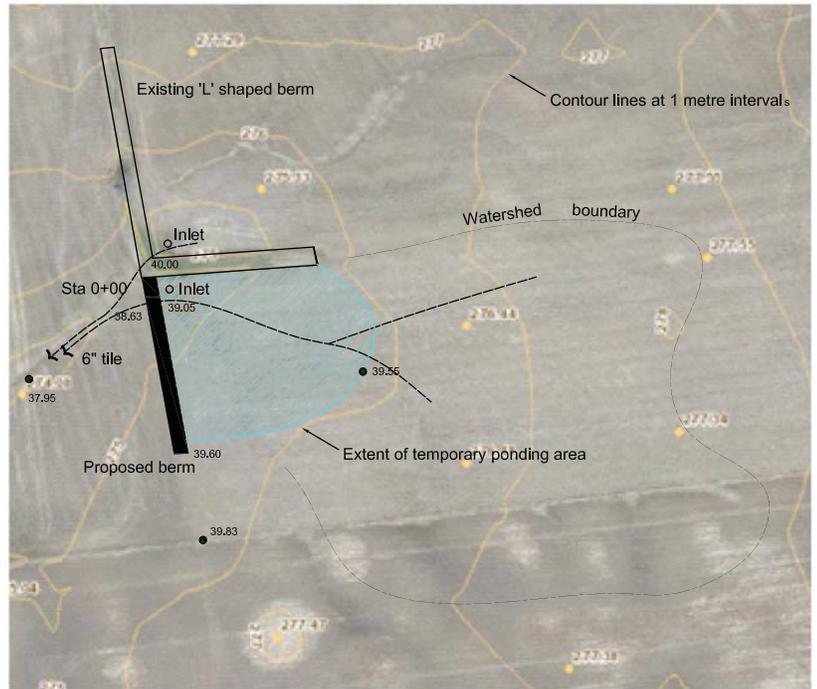
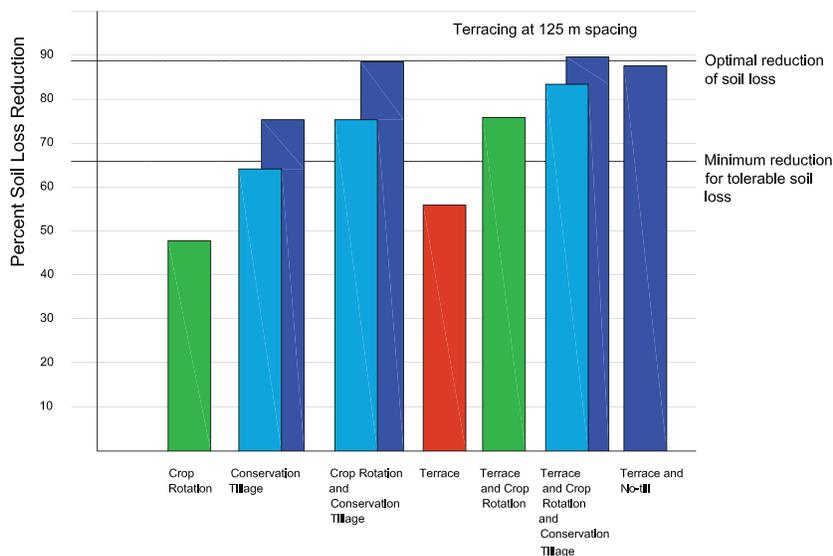
Using the Universal Soil Loss Equation (USLE) various cropping, tillage and structural erosion control scenarios were modeled to estimate potential soil loss under different practices. The landowner can better visualize the preferred cropland conservation farm plan. The 800 tons of soil scraped out of the 'L' shaped berm sediment disposition area is estimated to be about 50-75% of the overall soil eroded from the upland field.

Using the universal soil equation (USLE) a number of management alternatives are evaluated based on soil loss reduction. It is preferred to adopt management options that maintain soil loss annually to less than 3 tons/acre/year and optimal soil loss is less than 1 ton/acre/year. The base management practices include fall ploughing and continuous row crops.
