North Kettle Creek Watershed Evaluation Project

Conservation Cropland Planning Options at Farm No. 2

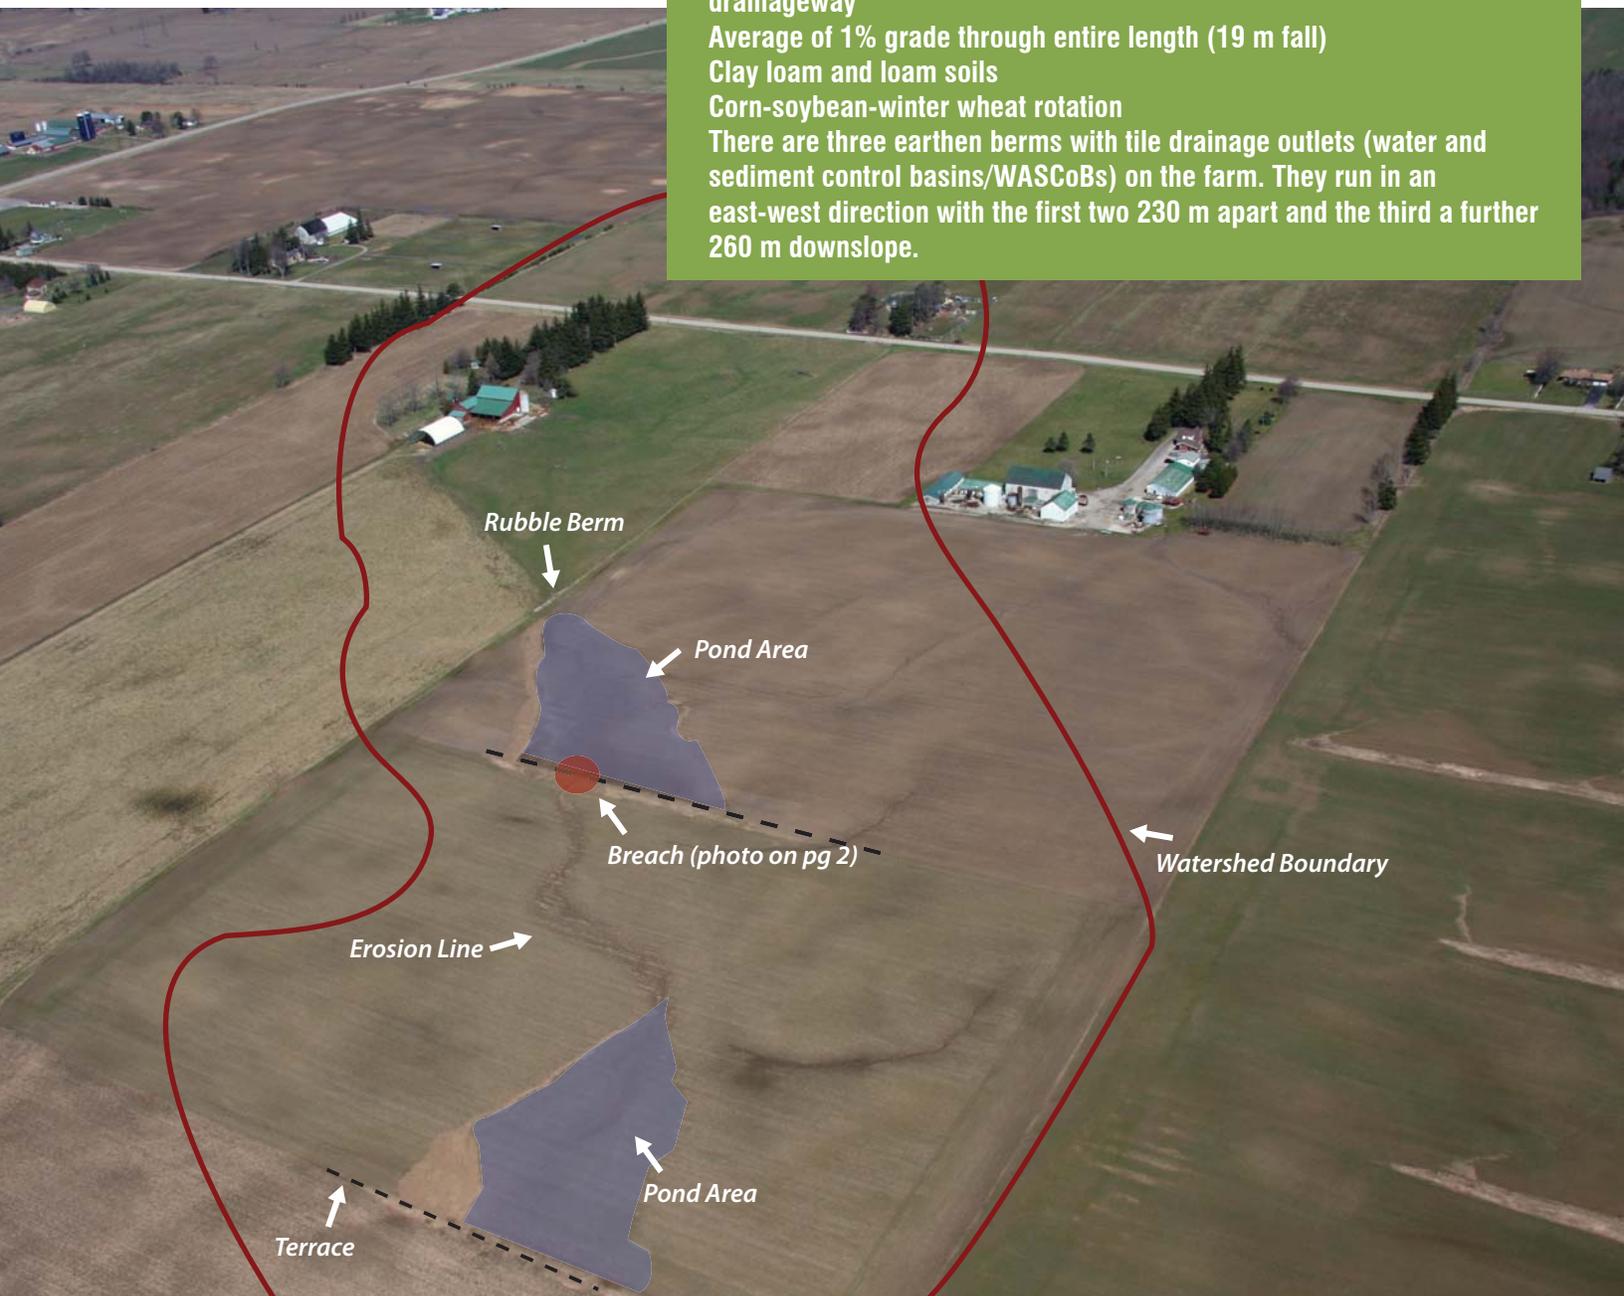
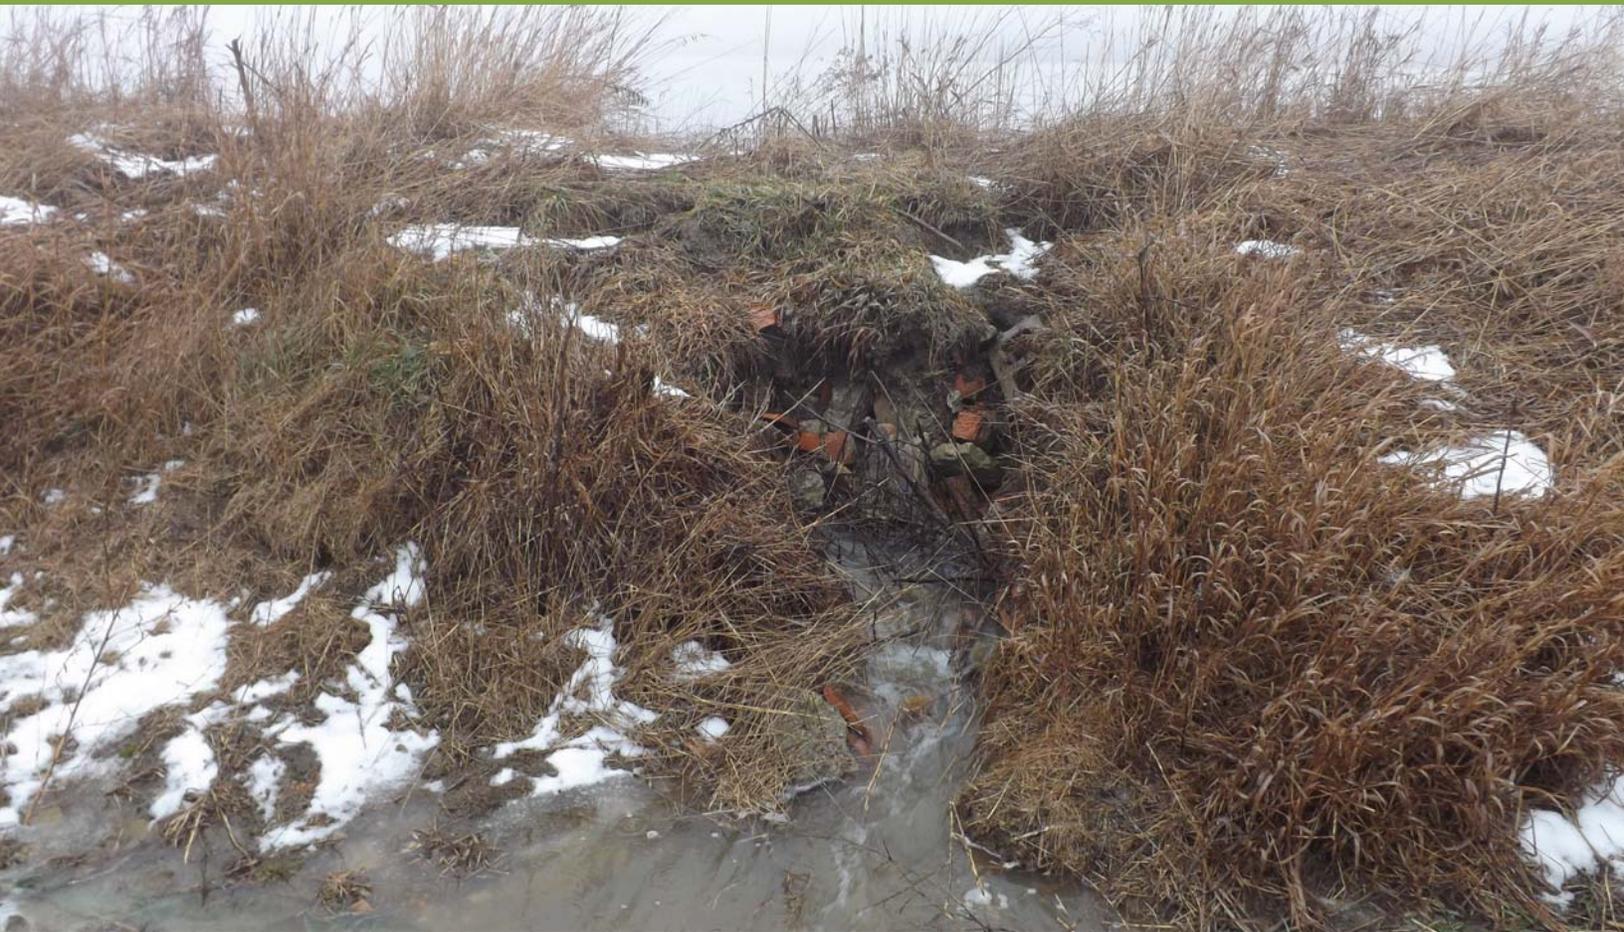
Figure 1: Field Topography and Other Details

50 hectare watershed, linear in shape with a 1700 metre long drainageway

Average of 1% grade through entire length (19 m fall)

There are three earthen berms with tile drainage outlets (water and sediment control basins/WASCoBs) on the farm. They run in an east-west direction with the first two 230 m apart and the third a further 260 m downslope.

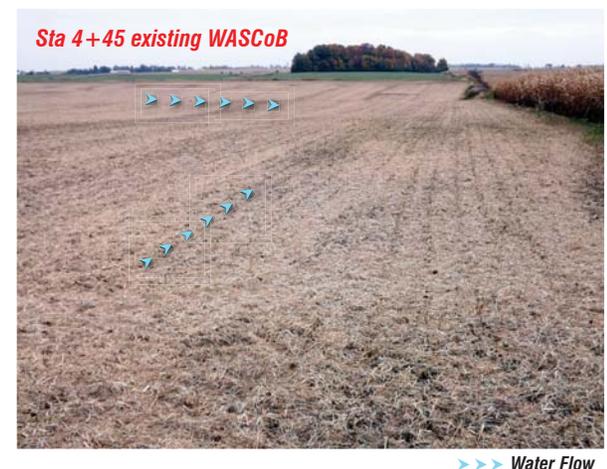
Broad Base Berm

- allows farming over the whole structure
- may be built on slopes up to 8 percent
- construction results in steeper land slopes
- higher cost, more soil used in construction

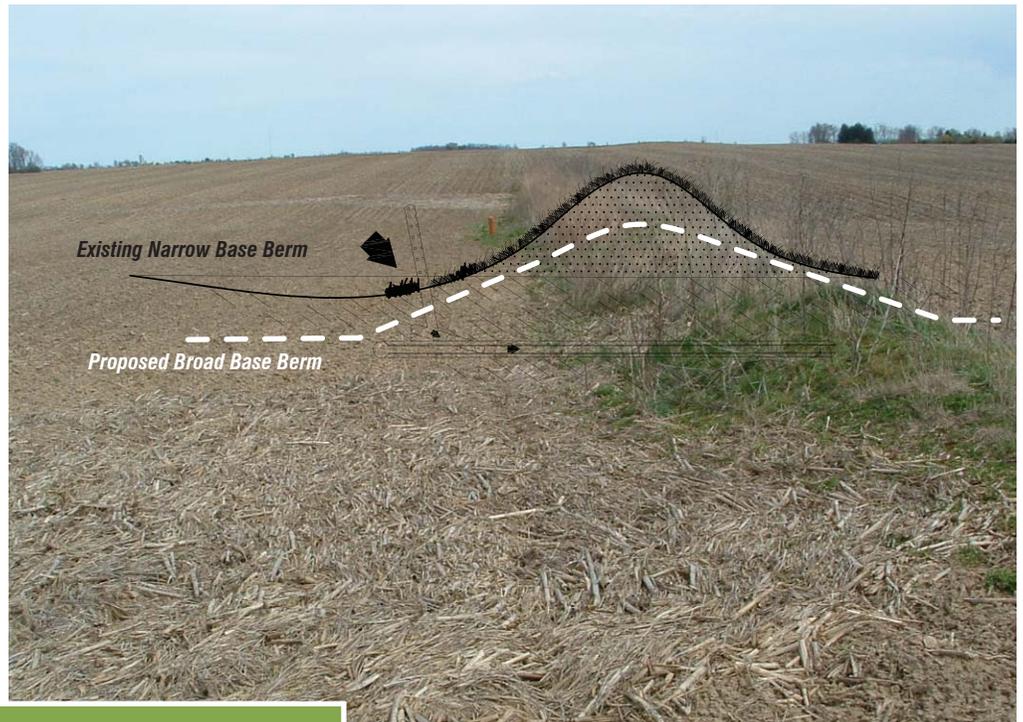
Existing Narrow Base Berm

Proposed Broad Base Berm

- If additional WASCoBs are added on this property, consideration may be given to *broad-based berms*.
- The proposed alternative design would use about 35% less soil (84m³) for construction than the existing system and the whole area could be cropped.
