# North Kettle Creek Watershed Evaluation Project

## Conservation Cropland Planning Options at Farm No. 3

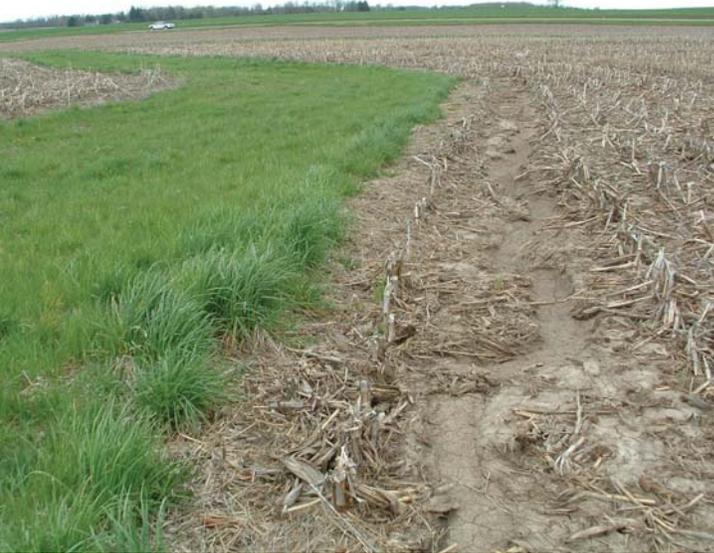
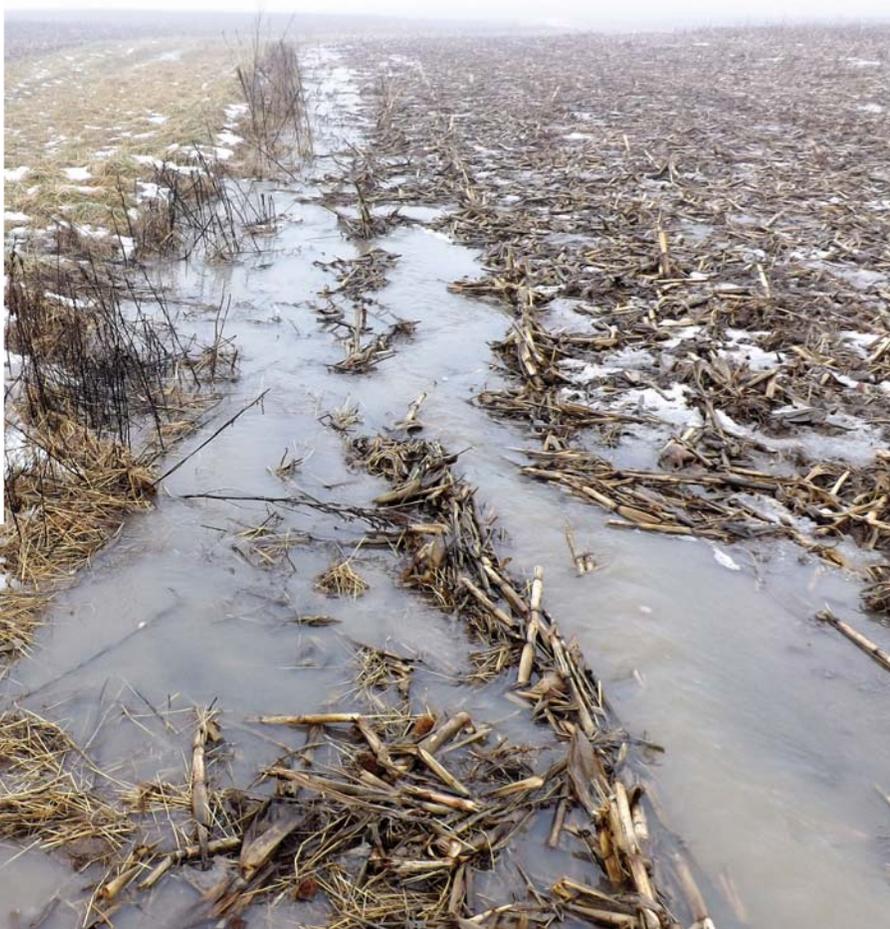
Headland deflects surface runoff away from waterway causing rill erosion

- inconsistent cross-section shape of waterway continues to cause scour (to meet slope/soil and runoff needs, waterway should be wider and shallower)
- headlands have established from working the field parallel to the waterway
- runoff not able to enter waterway causing gully formation
- side slope rill erosion still exists
